A REAL CASE STUDY ON THE STATE OF CORROSION OF THE SPANISH BOATS

José A. Orosa, Juan José Galán, and Mar Toledano

Key words: boat, corrosion, Spanish, case study.

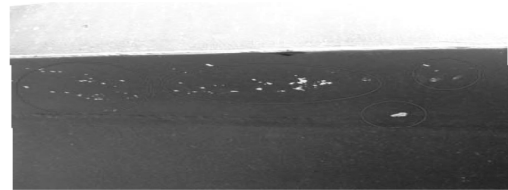
Fig. 5. Failure in the patent.

In 10% of aluminum boats it was found that, although it appears clean, there is a fine aluminum oxide layer which prevents adhesion of the primer, as seen in Figs. 4 and 5. Paint coating treatment of aluminum was developed more carefully than for steel. Further, primers must resist the maximal aluminum dilation with temperature and surfaces. This treatment is very sensitive to the behaviour of aluminum as an anode, causing peeling and blistering during treatment.

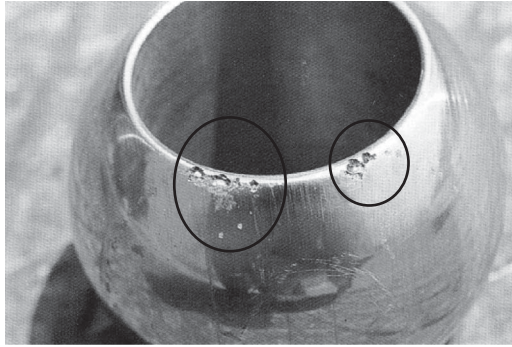
Simultaneously, corrosion was observed in the sea inlet and bottom valves, as evident in Fig. 6, thus concluding that sea

Fig. 6. Pitting corrosion on the ball of a foot valve 1 of stainless steel.

inlet damaged valves are of low quality, exactly similar to the quality of the valves employed in irrigation. Therefore, they were replaced. Finally, corrosion in hydraulic oil tanks and in fuel tanks was related to the lack of grounding and corrected by connecting the hydraulic tank and servo to mass, and painting after suitable treatment.

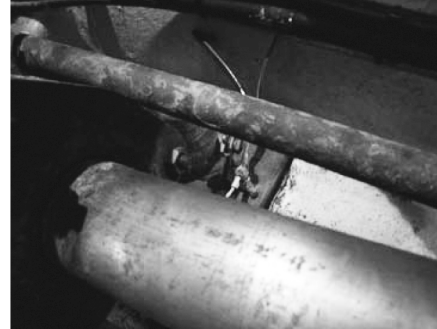
Fig. 10. Untreated copper pipe.

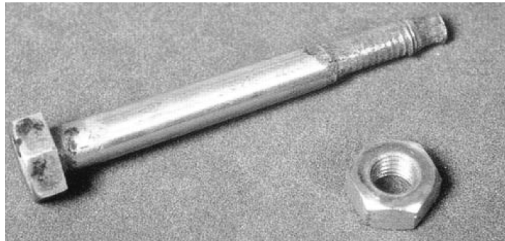
Fig. 7. Stainless steel bolt.

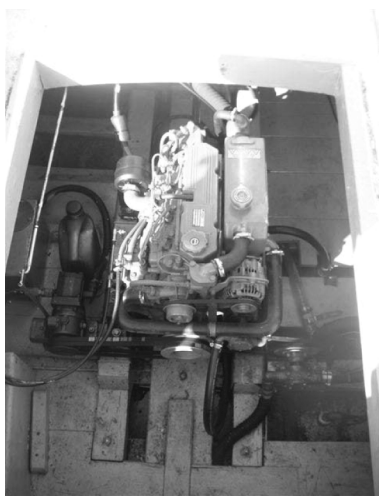
Fig. 8. Inboard engine.

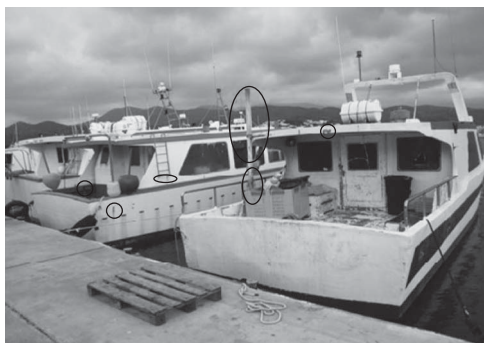
Fig. 9. Fishing boats between 8 and 14 meters.

In wooden or glass fibre reinforced polyester from 8 to 14-meter long vessels, the main problem observed was to prevent the high corrosion in aluminum tooling, such as windows, wipers and engine control panel, as we can see in Figs. 10-12. The initial analysis revealed that the use of aluminum windows, typically employed in land application, showed poor coating treatment that consequently led to a rapid deterioration of these elements. Employing aluminum materials in naval constructions would increase the life and robustness of these elements. Particularly, some equipment under special conditions were considered. For example, the "alador" is an element in constant contact with splash and spray, and therefore, it needs to be protected with suitable paint treatment before bringing it into contact with mass. In

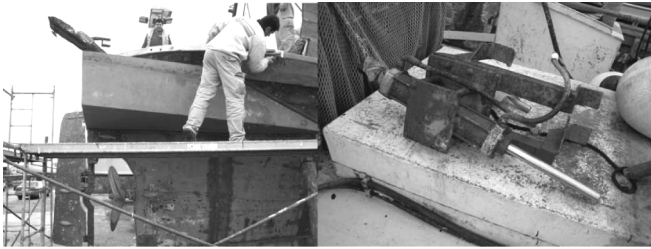
Fig. 13. Corrosion in steel rudders and servo drive components.

To protect steel rudders and servo drive components from corrosion, the best solution was to place an anode in both the rudder and the stern, near ink. Another solution was to apply a proper paint treatment, starting always with clean metal grade blasting. However, the only solution for corrosion of the tail axis was prevention. In this case study too this was the same problem that occurred over the past two years, entailing two major repairs on the tail shafts of wood boats. At the same time, a similar corrosion in the shaft and piping in drag boat hull glass fibre reinforced polyester (GFRP) vessels was observed, as we can see in Figs. 18 and 19. In these vessels, usually between 20 and 25 years, it generally presents the

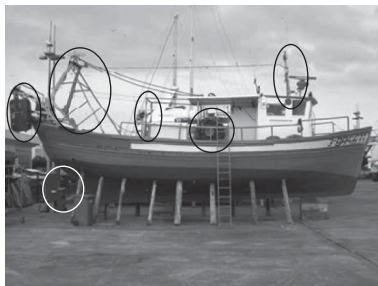
Fig. 14. Corrosion in the fishing system materials, structure or idler winches, trawl winches, cables and towed trawl doors.

In the trawl wooden hull boat, Figs. 13-17, steel bolts were replaced with stainless steel bolts and, at the same time,

corrosion in the fishing system materials, structure or idler winches, trawl winches, cables and towed trawl doors was reduced in the main engine bed, corrosion was reduced if they were connected to sacrificial anodes and, as in the previous sections; corrosion in the metal pipes was prevented.

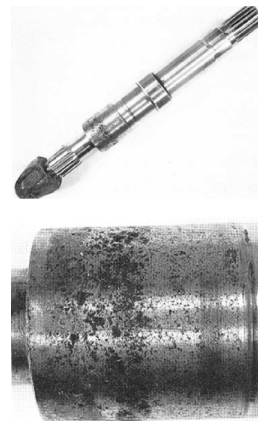
Fig. 16. Corrosion of connecting bolts or keels.

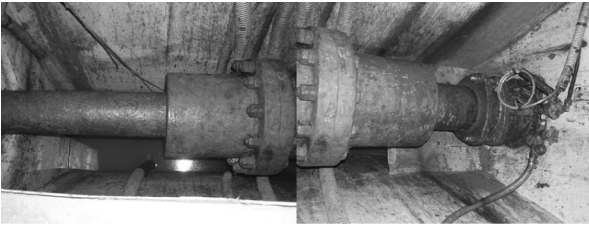
Fig. 18. Localized corrosion on the shaft and its intermediates.

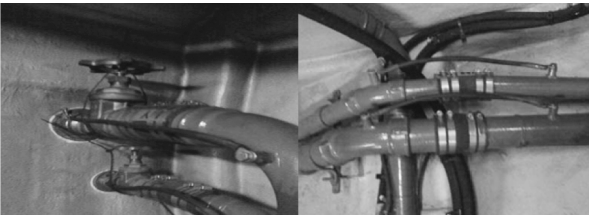
Fig. 19. Corrosion in pipe systems.

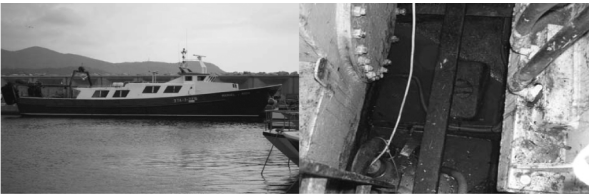
Fig. 20. Gradual corrosion of the steel hull.

In this section we will consider three groups: drag steel hull boat, passenger boats less than 24 meters in length and siege steel hull fishing boats. In drag steel hull boats, Fig. 20, corrosion in the tail shaft was observed. In this instance, it must be noted that most of the tail axes of these vessels are mounted on AISI 316L steel.

To solve this problem the bronze shirts need to be replaced by composite materials, resulting in isolation of the tail shaft with respect to the hull. However, this phenomenon, which occurs most obviously in fibre vessels, was minimized by installing a brush holder graphite axis which sends the parasitic galvanic current to mass or directly to the hull.

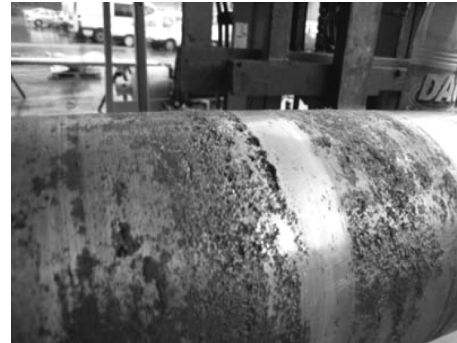
Fig. 21. Corrosion tail shaft.

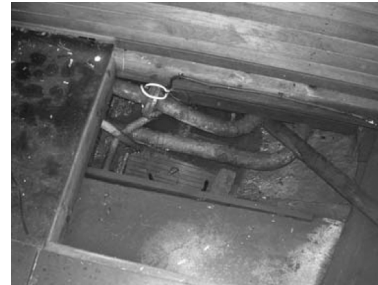
Fig. 22. Pipe corrosion in services.

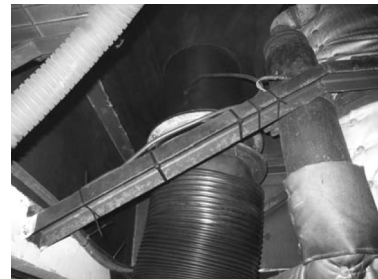
Fig. 23. Silent leaks and corrosion in the main and auxiliary engine.

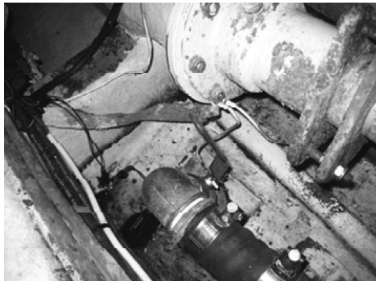
In these boats, another related problem was pipe corrosion. It was later concluded that continuity in the pipes needed to be tested, especially in the transition between the antivibration neoprene caps. Further, the use of a flanged pipe was recommended, which minimized corrosion threads and leakage, providing more robust services. Next, Figs. 21-24 reveal a few examples of pipes and the electrical continuity of these links horn cap and bottom valves.

Fig. 24. Pipes and electrical continuity of these links horn cap and bottom valves.

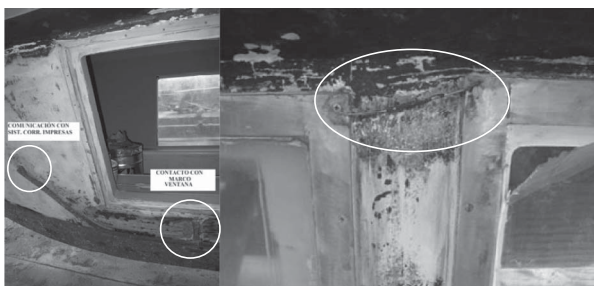
Fig. 25. Corrosion of screws and steel frames in the underwater sight glass windows.

screws and steel frames of the underwater sight glass area. Consequently, it was replaced by AISI 316 stainless steel screws and joined to mass.

It was proposed to employ stitched windows and frames to prevent this. To reduce cavitations in high-speed propellers two options were proposed; a variation of the maximum propeller working regime or to replace and install high-strength stainless steel blades.

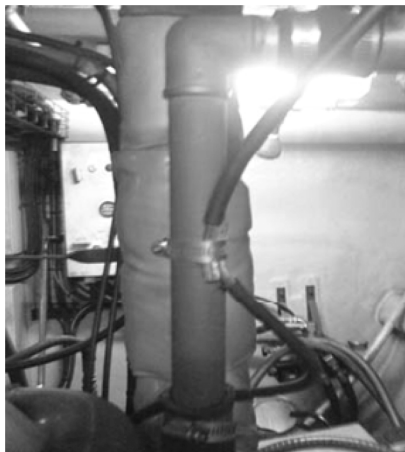
Fig. 26. Corrosion failure to protect main engine and pipes.
