SIPHONING SEA WATER BACK INTO THE ENGINE IN FAST BOATS

Osman Azmi Ozsoysal

A failure investigation has been conducted on the exhaust system of a high speed marine diesel engine in Turkish ambulance boats. Premature failures were reported on the poor starting, on the loss of power, on the lubricating oil leakage and on the engine overload. It was observed some significant tracks of sea water found its way into the exhaust passages from condensation of the salt water vapour and also from entering some sea water into the exhaust system. In order to initiate a more accurate cause investigation, the engine went through an overhaul inspection, in which it was determined that there were corrosion and some deposits throughout the exhaust system. After performing the systematic cause analysis of the engine damage, it is concluded that erroneous design decisions cause to siphon sea water back into engine, doing expensive damage. Ever since water has been used to cool exhaust gases, there will be many cases of engines flooding with water from the exhaust system. Recognizing the potential problems mentioned in this paper, a wet-exhaust system is recommended to keep water out of all small and

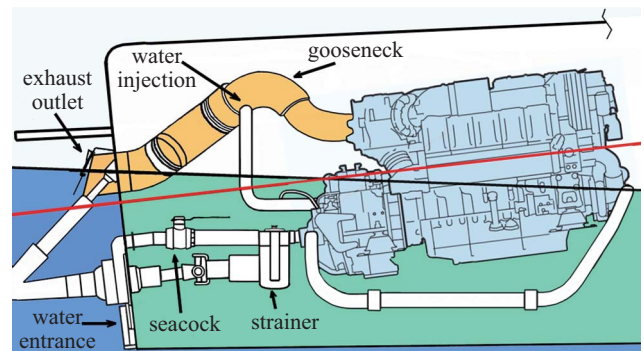
Original exhaust line configuration combined with the open-circuit sea-water cooling system is illustrated in Fig. 1. A goose neck arrangement is preliminary thought to prevent to lift the cooling-sea water. Beyond the water-injection point, good quality wire-reinforced steam hose is mounted. Transom stern dives into the depth a bit more than service condition during the highest speed. This can be clearly seen from the coloured region below the black thick line at Fig. 1.

Neither the cover plates, nor the goose neck prepared any appropriate solution in order to reduce the risk of sea water splashing back onto the inner surface of exhaust line and rusting them. Major problem is here that the sea water line is level with or above the exhaust pipe bend.

Fig. 1. Exhaust line and cooling sea water arrangement of ambulance/health boat.

Recognizing those potential problems mentioned above, one can say that a wet-exhaust system must be designed to keep water out of all engines. A water-lift system should be designed to prevent siphoning through the raw water pump when the engine is stopped. If this is accomplished through the use of a siphon break device, it shall be installed at the top of a loop that shall rise high enough to assure that the high point where the siphon break device is installed will always be above the water level surrounding the boat.

Depending on the design of the boat, the condition of its loading and the sea conditions encountered, this loop must be at least 0.5 meter above the water line at repose. The siphon break point must also be arranged at 0.2 meter above the water line.

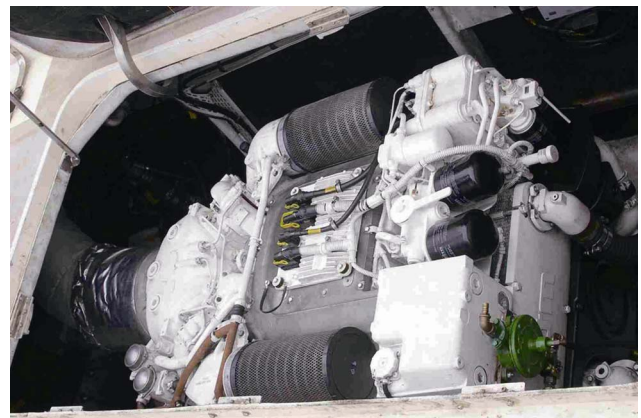
Engine room arrangement is overcome with some difficulties due to the narrow suitable area. Engine is mounted under the deck casing as shown in Fig. 2. Air intake is just after a couple of dry type filters which its openings are replaced directly towards to the machinery (engine) room.

Fig. 2. Looking at the machinery room.

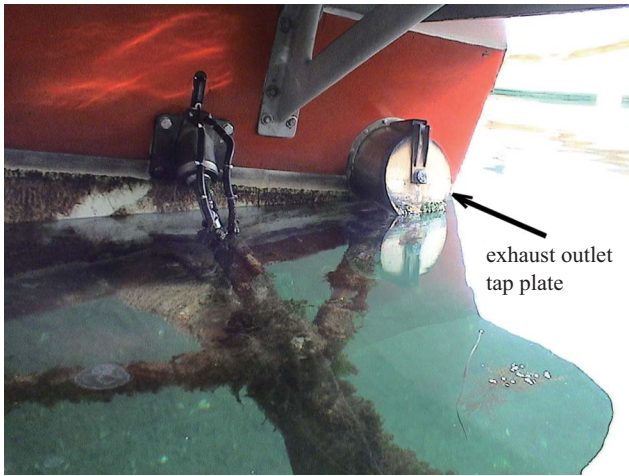
Exhaust outlet position at the keel level of transom stern is shown in Fig. 3. A convenient number of zinc anode plates were placed next to the exhaust outlet. A circular steel tap plate was also placed at the mouth of the exhaust outlet.

Fig. 3. External view of the ransom stern and the exhaust outlet.

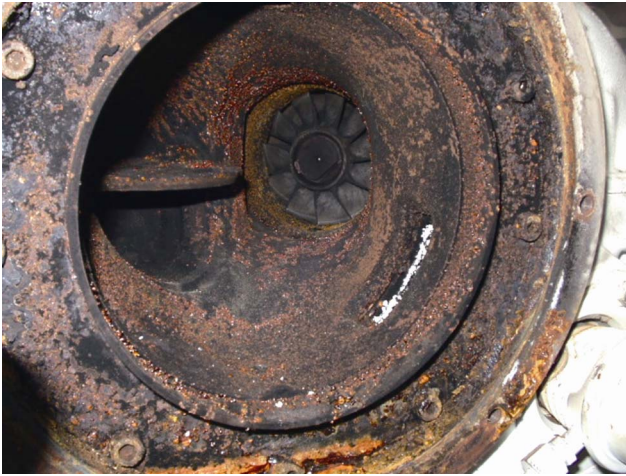
Fig. 5. Rust and corrosion signs at the exhaust turbocharger outlet.

Figure 5 shows the penetration size of rusting at the exhaust turbine outlet due to the water surging back into engine when the boat heels to extreme angles.

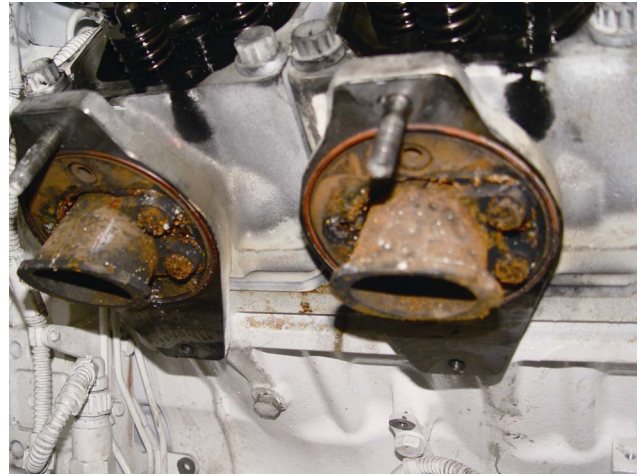
Fig. 7. Appearance of widely diffused rusting at the exhaust passages.

Connecting pipes between the cylinder heads and exhaust manifold, which is in fact simple cast iron unit, were so rusty that could not be re-used and repaired. As shown in Fig. 7, the tightening bolts are also worn because of the corrosion and the rusting.

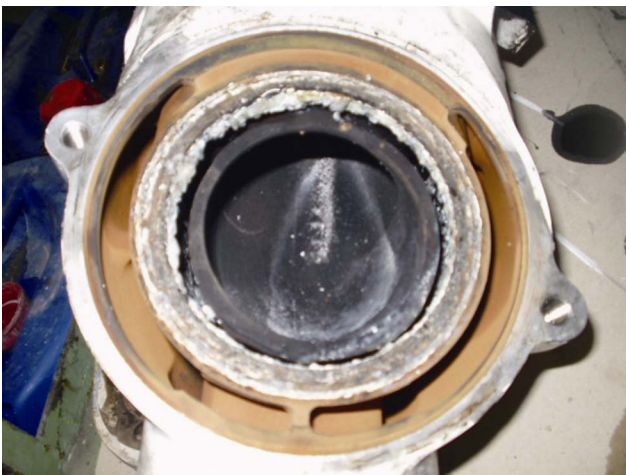
Fig. 6. Sea salt, mildew and less rusting before the turbocharger inlet.

Rusting was observed to be diffused widely throughout the exhaust manifold. Because sea water vapour met the enough time to be condensed immediately after stopping the engine without running at idle speed for a while. When shutting down the engine whatever water vapour was in the pipes condensed and turned back into a liquid. On short trips, the sea water never had a chance to get hot enough to turn back into vapour and just stayed in the system and rust away the pipes. Some contours of sea salt because of the evaporation and some mildew remains can be easily seen in Fig. 6.

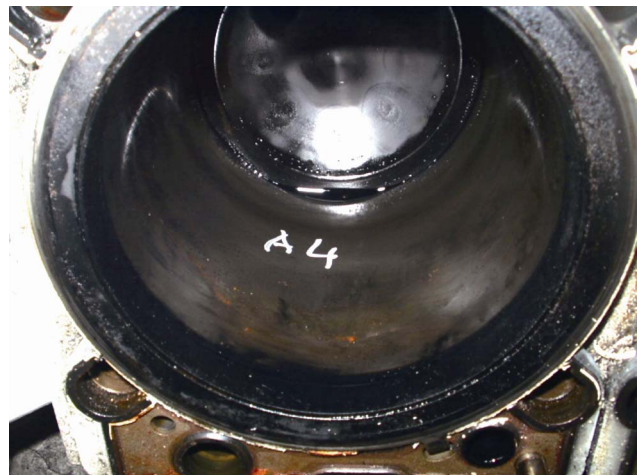
Fig. 8. Local rusting on the liner's inner surface.

It was noticed less amount of surface rust on liner, as shown in Fig. 8. This hazardous was noted at the cylinder no. 4 of block "A" which is nearest one to the exhaust turbocharger. In other words, some of the vapour got a chance to reach to the combustion bowl without condensing earlier. Some exhaust valves, which remained open after stopping the engine, played a major role and accelerated the event. So, the condensate caused the surface rust. A sample of lubricating oil was tested at an accredited laboratory and then no water leakage or evidence is observed from the lubricating oil analysis. The riser gaskets were also found without suffering any damage.

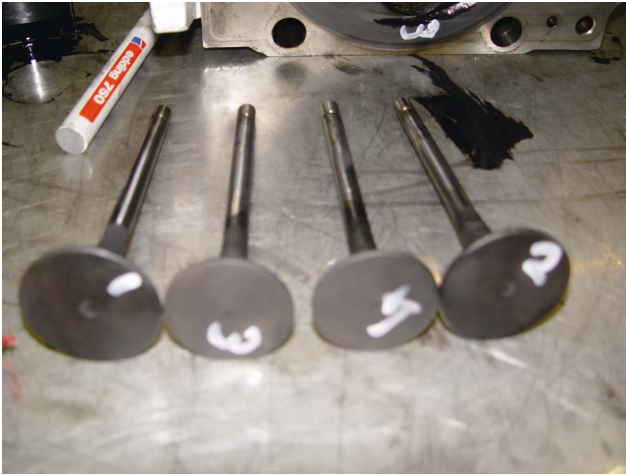
Exhaust valves of cylinder no. 4 were found to be intensively affected by the sea salt and the rusting. The sea water evaporated and leaved the salt crystals on the exposed surface of an exhaust valve because of the gas flowing at high temperatures. Overtime, the crystals caused rust to form. When the valve became sticky, it caused more water to be drawn backward from the exhaust elbow discharge into the engine. Figure 9 shows the rusty exhaust valves numbered 1 and 2.

Fig. 9. Less evidence of rusting on the exhaust valve skirts.

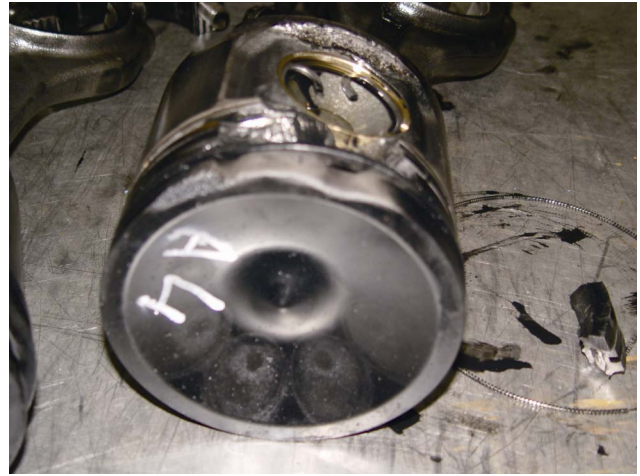
Fig. 10. Pitting and sea salt contours on piston crown.

It was also observed similar salt contours on the piston crown just across the exhaust port skirts. Abnormal temperature distribution and bad fuel injection caused the remarkable pitting on piston crown as shown on Fig. 10. Compression ring collar and grooves just above the gudgeoned pin were seemed to be damaged due to the abnormal heat absorption. Side part of the piston crown was even found to be melted.

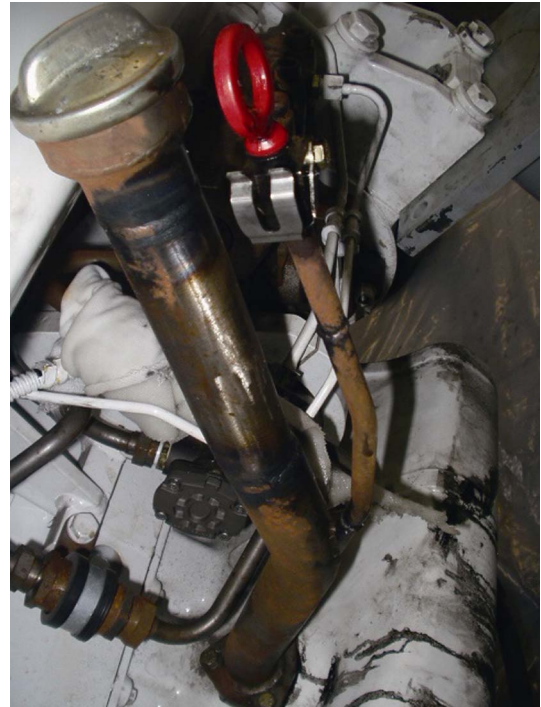
Fig. 11. Oil dipstick pipe, its clips and oil mess.

on the top side of engine. Less oil leakages were seemed around the seals between cylinder head and engine block, around of the injectors due to the high oil temperature and high pressure. Dirty oil leakages were specially concentrated near by the crankcase, around of the oil dipstick pipe. These were because of the high oil pressure in crankcase due to the much oil mist. First precaution against to the failure was to add a clip to the oil dipstick to prevent removal from the oil dipstick pipe. Figure 11 shows the current condition of oil dipstick pipe, its clips and oil mess. Further regulation was introducing of a check valve at the charge air intercooler which will allow the oil drainage during idle and no operation and that would be closed with increasing the charge air pressure. Crankcase ventilating circuits were also controlled and oil pressure was gauged. Crankcase ventilating filters were changed with new type of one's due to the clogging. However, all these arrangements were not just right solutions for preventing the irrevocable hazardous.

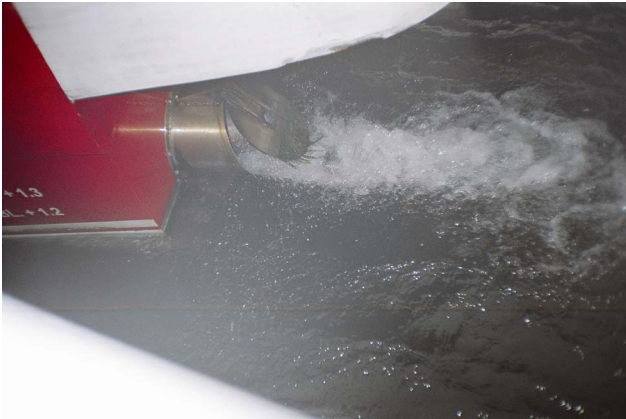
Fig. 12. Opening of the exhaust tap and black smoke.

Exhaust outlet tap was another source of failure and it was incapable to prevent flowing the raw water back into the engine. The tap is mounted at the top of the outlet pipe with a simple hinge, so it could just be controlled by a soft spring. Although a goose neck form was employed on exhaust line after the turbocharger, its form was improper since it had a slightly rounded elbow shape. Besides the junction point of hot exhaust and sea water was inappropriate. As shown in Fig. 1, the geometric form (slope) of goose neck could not help to prevent flooding some sea water through the former segment of exhaust line. Whereas the junction point should be selected to set at the lower skirt of the goose neck to cut down the mist formation. These all increase the possibility of water flooding through the turbocharger. General form of exhaust line, as shown in Fig. 1, gives important clues to explain how this kind of hazardous happens in the ambulance boats. Even if the exhaust outlet was normally above the waterline, water siphoned into a heeled or well-laden boat, as mentioned previously. It was boosted the exhaust pipe by high seas; or, in an otherwise calm anchorage, be forced up the pipe by repeated wakes from passing boats. This phenomenon is known as water hammer.
