Case Study of Coastal Erosion and Measures at Kezailiao Coast, Taiwan

REVIEW

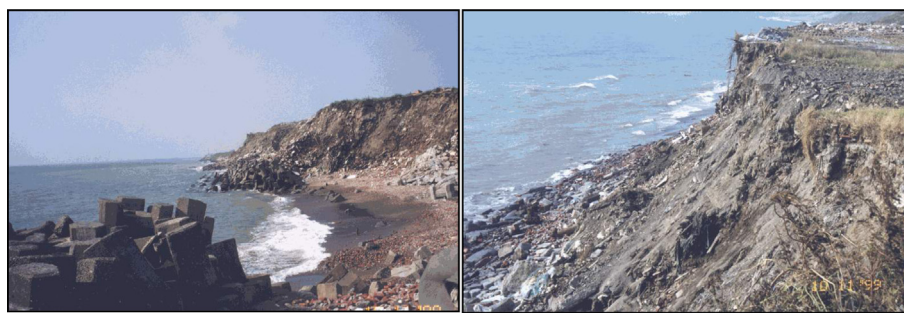
Fig. 4(a) shows coastal cliff areas at the Chikan Cliff Coast. The cliff is composed of mudstone, shale, sandstone, fine sand, gravel and loam covering on the surface. The base of the cliff is filled with debris which has fallen from the cliff. The total

length of the coastal cliff is 610 m with the height ranging from 2 m to 6 m. Details coastal cliff erosion are demonstrated in Fig. 4(b). The erosion of coastal cliff takes the form of abrupt large-scale land sliding or the more continuous failure of small portions of the cliff face. The recession of the cliff is caused by liquefaction of sea water induced by infra-gravity waves, direct heavy rain wash, and large waves in typhoon events. Waves travelling on the high sea level act at the base of the cliff to remove the accumulated talus and lead to cliff erosion and shoreline retreat.

Fig. 4. Coastal cliff at Chikan cliff coast: (a) side view; (b) close view.

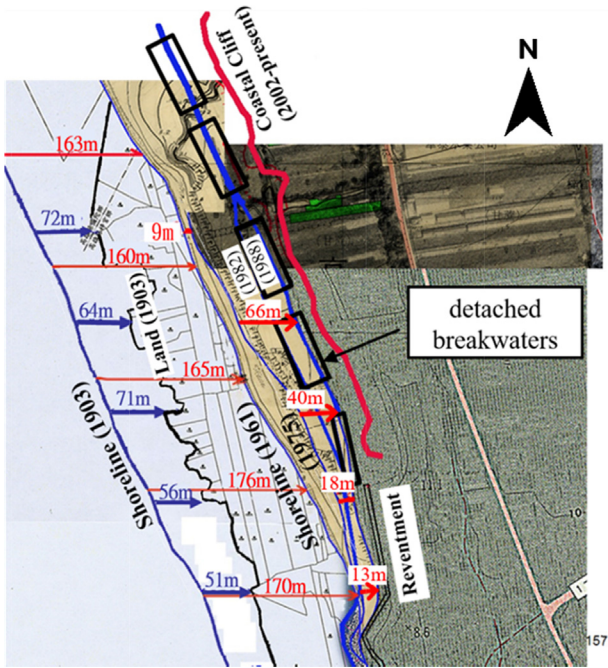
Fig. 5. Analysis of shoreline changes (1903–2002) using district maps of Chikan cliff.

Up to now, the shoreline has reached the toe of the coastal cliff. Continuous erosion has occurred for almost a hundred years according to the analysis from overlapped maps. Average beach erosion in the Chikan Coast was around 2.8 m per year during the 111 year period. Coastal cliff recession slowed down after the completion of 5 units of detached breakwaters built from 1981 to 1983 (see Fig. 5).

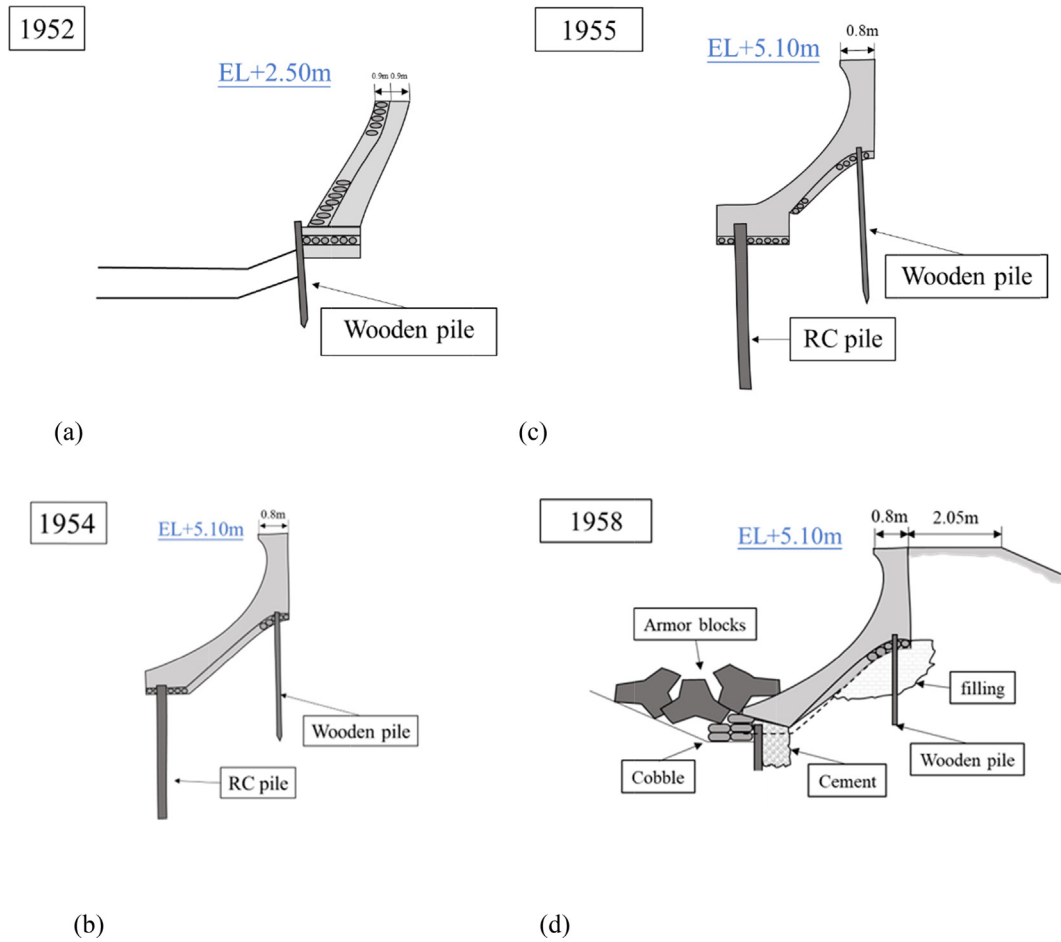
Fig. 9 depicts different types of revetments which were constructed at a distance from or very close but parallel to the shoreline. Note that the revetment began as a nearly vertical concrete wall in which the core was filled with sand mined from the beach (Fig. 9(a)). Then the revetment was modified into a concave and inclined shape with a thin concrete face, as shown in Fig. 9(b). The front face was designed as concave-type to decrease wave run-up and overtopping. Fig. 9(c) demonstrates that the toe protection was added and reinforced using a rubble mound design. More recently use of combined concave and inclined shapes with armored blocks was utilized to reduce wave run-up and deflect the wave swash upward for preventing water from running over the wall (Fig. 9(d)).

Fig. 9. Different types of revetments at Kezailiao Coast. (a) nearly vertical shape; (b) concave and inclined shape; (c) concave inclined shape with rubber mound; (d) concave and inclined shape with armored blocks.

According to the survey of WRA, concrete walls with rigid structures and vertical or concave faces reflect wave energy back to sea, leading to standing waves with higher energy accumulated in front of the base at Kezailiao Coast. This could cause soil fluidization and failures of the structures. The well-known Kezailiao Coast is called “Golden Coast” because a stockpile of armored blocks have been

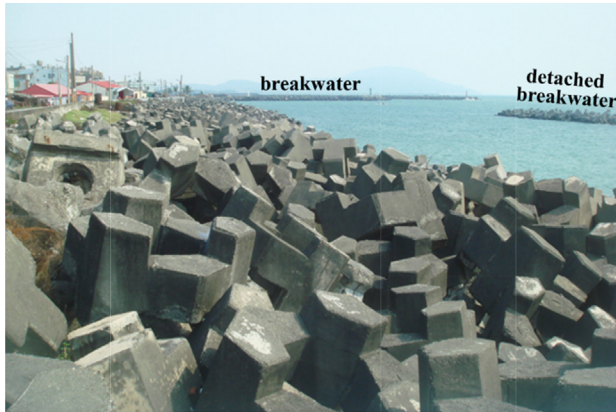
built to protect life and properties during typhoon events. Fig. 10 depicts the typical protection design of revetments with a riprap of a large amount of armor units at Kezailiao Coast. It is worth noting that the water depth is about 5 m in front of the base of the revetment due to wave reflection induced scouring. A number of studies from field surveys have indicated that scouring tends to develop at the toe of revetments, causing failures of constructions [9,18]. Based on the analysis and the later discussion

Fig. 10. Coastal prevention work using a stockpile of armored blocks causing water depth to be deeper in front of revetments at Kezailiao Coast.

by [8], the presence of a seawall or revetment tends to withhold sediment from the littoral system when erosion occurs. This results in the rapid erosion of adjacent unprotected coasts. The accumulation of reflected and incoming waves in front of vertical seawalls or revetments brings about erosion that causes beaches to progressively decrease with distance from the structures. Ou et al. [13] concluded that improper design of seawalls and revetments that are built too close to the shoreline could result in accelerating disappearance of sandy beach and excess erosion of unprotected adjacent properties.

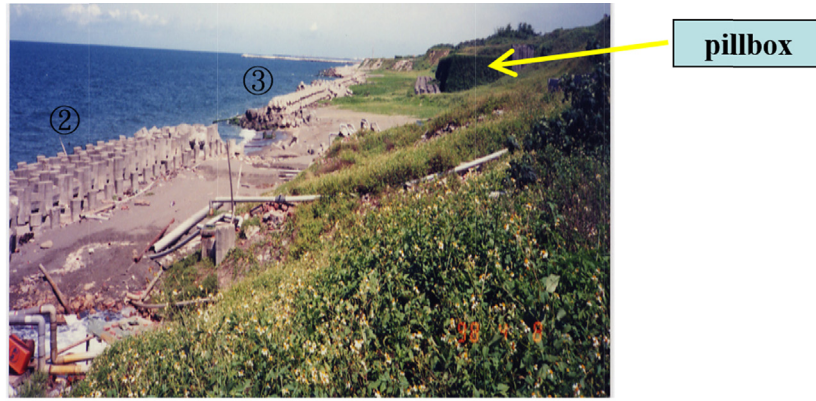
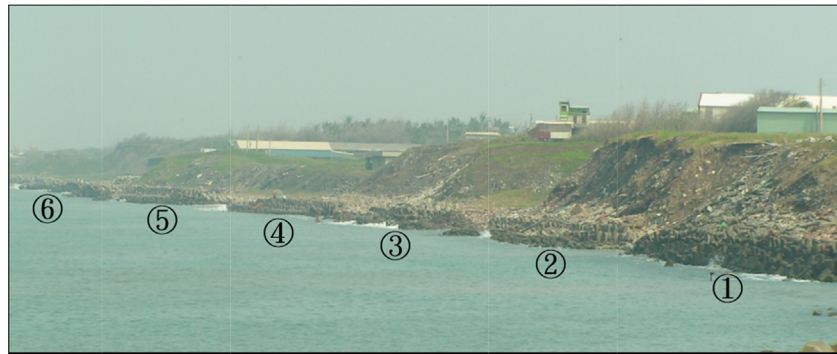
local shoreline. Six units of detached breakwaters were built at Chikan Cliff Coast near the shoreline to protect storms and waves from reaching the eroded cliff from 1981 to 1983. Fig. 11 presents an alignment of detached breakwaters installed at Chikan Cliff Coast. Each segment of the detached breakwaters is 80 m long, 3 m wide, and 1 m above mean sea level, with a 30 m gap distance between two breakwaters. This prevention work has been shown to mitigate the serious erosion of the coastal cliff [8]. The grasses have grown back and the army pillboxes still exist after the construction of detached breakwaters in front of the naked cliff.

Fig. 11. Grass regrown after construction of detached breakwaters at Chikan Cliff Coast.

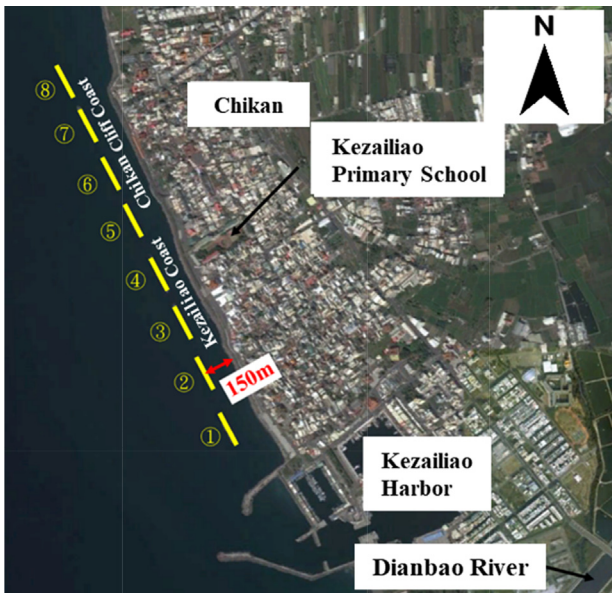
As a result, 8 units of detached breakwaters were constructed from 2005 to 2014 along the Chikan Cliff Coast and Kezailiao Coast. Fig. 12 shows the alignment of detached breakwaters which were built at about 5 m water depth and an offshore distance of 150 m. Each segment has the following dimensions: 130 m long, 9 m wide, and 0.5 m high, with a 45 m gap distance. The geometry of the structures is designed as a trapezoid shape with a slope of 1:3 on the front side and 1:2 on the back side. Wave refraction occurs at the tip of the breakwater to reduce wave energy and cause sand deposition in the shadow zone. Detached breakwaters have been shown to decrease coastal erosion in the lee of breakwaters, but without producing a salient or tombolo behind the breakwaters. Notably detached breakwaters are constructed by accumulating 3–4 layers of armor units on a foundation of filter cloth and gravel ingredients which are easy to slide, roll or collapse in storm wave conditions. To maintain the coasts, the amount of armor units has increased with the increased number of typhoons. According to [8], a recent prevention work in Japan replaced old detached breakwaters with submerged breakwaters or artificial reefs to maintain the landscape and ecology. Coastal prevention work of detached breakwaters should include alternatives based on safety, landscape, ecology, attraction to water and budget.

Fig. 12. Eight units of detached breakwaters at Kezailiao Coast.

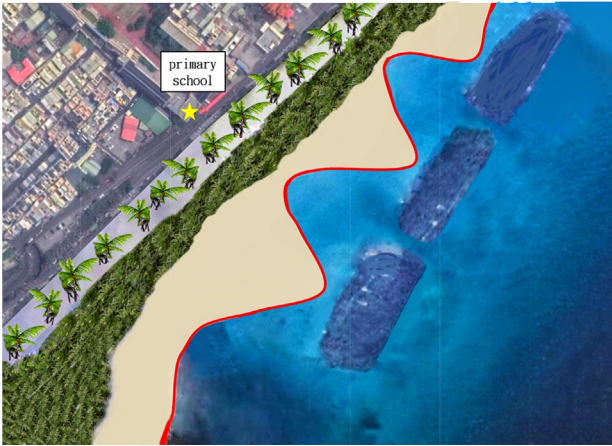
Fig. 15. New innovative submerged breakwaters combined with an artificial beach.

Beach nourishment is also conducted by putting sand in sandbags to create a buffer zone against storm surges and erosion. Moreover, a larger beach could protect coastal settlements, maintains a view of the ocean and space for leisure, and prevent obstruction or destruction of the natural environment for those organisms that rely on sandy spaces for habitat or reproduction. The addition of sand has been linked to high property values and increased tourism. The total volume of the supplementary sand is $56,250 \text{ m}^3$ which was calculated by the offshore distance of the sloping shelter areas from the submerged breakwaters. Fig. 15 shows a series of salient formed behind the 3 units of breakwaters. Notably, beach nourishment combined with a

submerged breakwater system could provide a reservoir of sand during times of low wave energy, which is resource that could eroded during a storm. We also focus on a coastal landscape design along a section of coastal line that has distinguishable features at Kezailiao Coast. Trees that provide sight-seeing and a promenade have been planted on the sandy beach at the waterfront of the coast. This measure is a combination of beach nourishment, submerged breakwaters and landscape design that provides a typical example of soft beach erosion control with more attractive coastal water regions.
