## AN EXPERIMENTAL FIELD STUDY USING A FLEXIBLE HIGH-STRENGTH NET BREAKWATER FOR SHORE PROTECTION

Jan, Chyan-Deng; Peng, Ta-Hsiung; Huang, Shih-Jen; and Hsu, Hung-Chu (2015) "AN EXPERIMENTAL FIELD STUDY USING A FLEXIBLE HIGH-STRENGTH NET BREAKWATER FOR SHORE PROTECTION," *Journal of Marine Science and Technology*: Vol. 23: Iss. 1, Article 14.

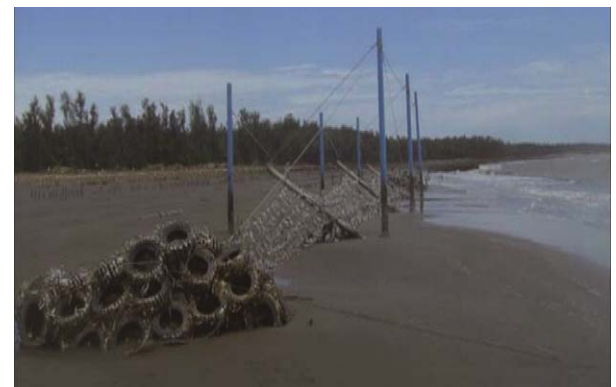
Fig. 7. The No. 1 flexible device and appearance of the beach after a typhoon on 2009/07/04, one month after the device was set-up. Rich sediment is deposited around the device. The bottom row of the flexible net (attached with tires) was buried by sediment.

the flexible breakwater. The flexible permeable wire net is not only used to prevent coastal erosion by reducing wave energy, but it also allows the deposition of sediment around the breakwater (see Fig. 7).

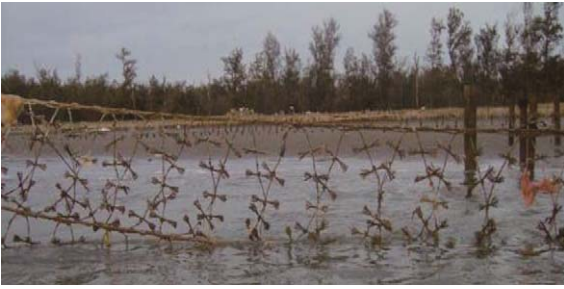
Fig. 8. Short wire fins attached to the wire nets of No. 2 flexible breakwater.

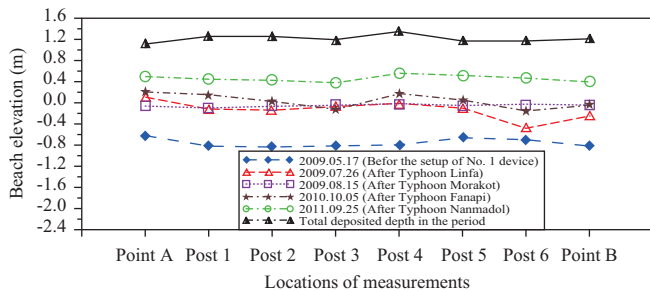
**Fig. 10. Temporal variations in beach elevation measured around the No. 1 flexible breakwater, before and after device set-up.**

The function of No. 1 device (installed since June 2009) has now been tested by the action of typhoons, such as Typhoon Linfa (June 19-22, 2009), Morakot (August 6-10, 2009), Fanapi (September 17-20, 2010), Megi (October 21-23, 2010) and Nanmadol (August 27-31, 2011). Results show that the flexible breakwater device effectively traps sediments and allows their deposition on the coast. Coastal bed elevation measurements H1, H2, H3, H4 and H5 were taken on 2009/5/17 (before the set-up of the device), on 2009/7/26 (after Typhoon Linfa), 2009/8/15 (after Typhoon Morakot), 2010/10/5 (after Typhoon Fanapi) and 2011/9/25 (after Typhoon Nanmadol), respectively. The deposition depth ( $\Delta H$ ) around the breakwater device two years after its set up was between 1.17 and 1.36 m (as shown in Table 2). Fig. 10 shows the temporal variations of beach deposition, measured around No.1 breakwater before and after its set-up (locations of measurements taken are referred to in Fig. 3). The blue-dashed line indicates the elevation before set-up, the red-dashed line indicates the condition after Typhoon Linfa, the

purple-dashed line after Typhoon Morakot, the brown-dashed dotted line after Typhoon Fanapi, and the green-dashed dotted line after the Typhoon Nanmadol. The solid black line shows the total amount of sediment deposition recorded between 2009/5/17 to 2011/9/25, and it highlights the sediment deposition on the beach after the set-up of No.1, showing an average deposition depth of 1.22 m. Fig. 11 shows the beach and the appearance of sediment deposition after the set-up of No.1 device, using a photograph taken on 2011/10/04, which provides further evidence of the deposition of sand on the foreshore area that has resulted in the shoreline shifting forwards towards the sea; thus avoiding beach erosion.

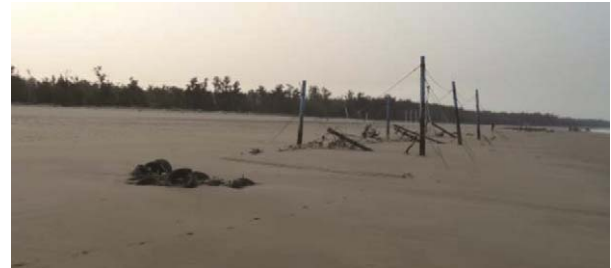
**Fig. 11. Beach appearance on 2011/10/04, approximately 2 yrs after the set-up of device No. 1. Rich sedimentation can be seen around the breakwater.**

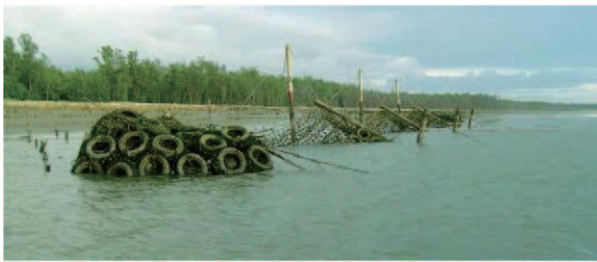
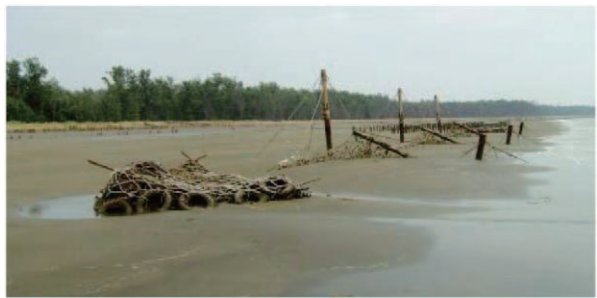
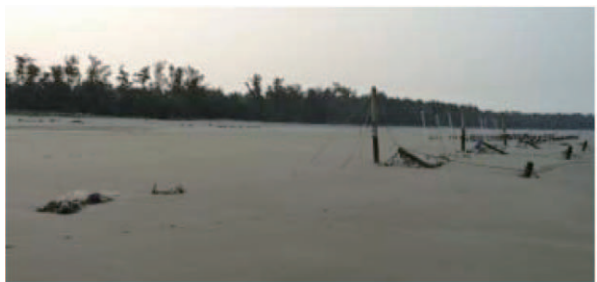
(a) No. 2 device on 2010/05/29

(b) No. 2 device on 2010/09/07

(c) No. 2 device on 2011/10/30

**Fig. 12. Temporal variation in beach appearance around No. 2 break-water device.**

Fig. 12 shows the temporal variations in the beach appearance around No. 2 device after its set-up. The photograph taken on 2010/05/29 shows the device surrounded by sea water (Fig. 12(a)); the photograph taken on 2010/09/07 shows the device buried by sediments up to about half its height (Fig. 12(b)); the photograph (Fig. 12(c)) taken on 2011/10/30 shows the triangular gabion and the flexible net almost fully buried by sediment. These photographs show that there has

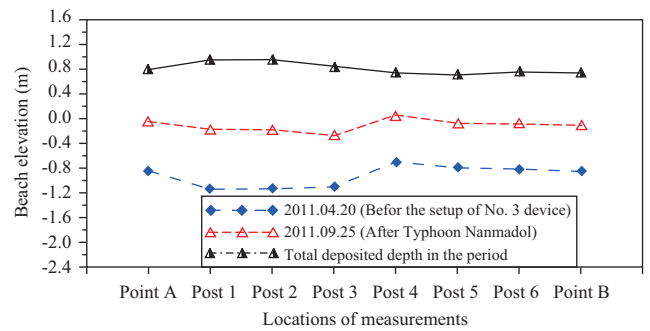
**Fig. 13. Temporal and spatial variations in beach elevation around No. 3 flexible breakwater.**

Installation of No. 3 breakwater was completed in April 2011, in the third-year of the field study. Table 4 shows the deposition depths of sediments around the device as being between 0.73 and 0.96 m after the action of Typhoon Nanmadol, and this reveals the ability of the flexible breakwater to effectively trap sediment and allow its deposition along the coast. The beach surface elevations around the device, measured on 2011/04/20 (before the device was set up, blue-dashed

line), and on 2011/09/25 (after Typhoon Nanmadol, red-dashed line), are also shown in Fig. 13. The solid black line shows the overall depth of sediment deposition, with an overall average of 0.81 meters. This provides further evidence that the improved No. 3 device performs well, and that it also has the ability to deposit the sediment on the foreshore area, which has resulted in shoreline protection. Fig. 14 illustrates the

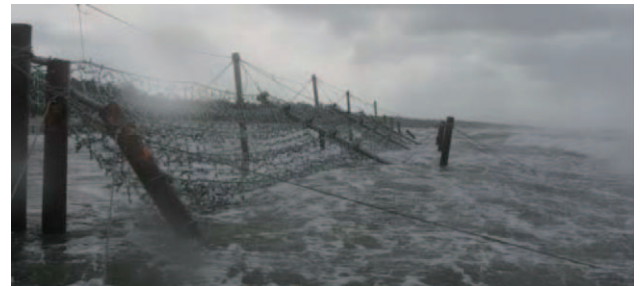
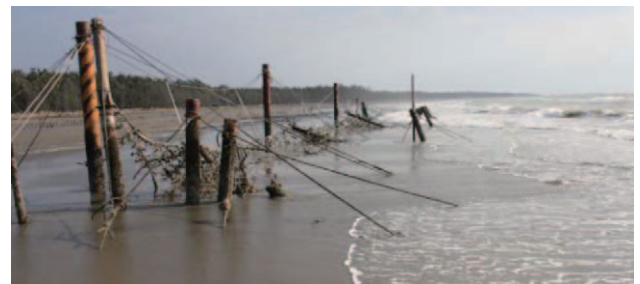
(a) No. 3 device under wave action on 2011/05/02

(b) Beach appearance around No. 3 device on 2011/09/26

**Fig. 14. Appearances of wave action and beach sedimentation after set-up of No. 3 device.**

condition of the device and the beach on 2011/05/02, and on 2011/09/26 after Typhoon Nanmadol. These figures show that the newly developed flexible device is strong enough to withstand waves that accompany severe typhoons, in addition to enabling sediment deposition.

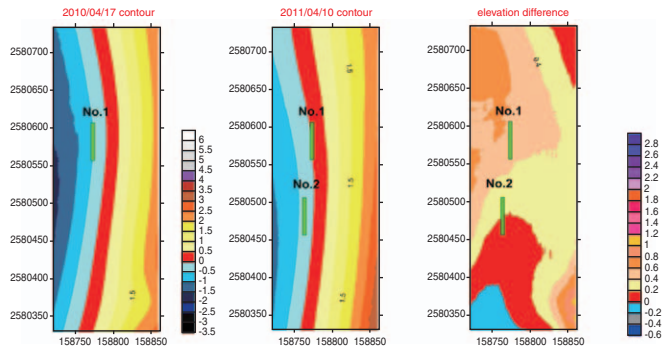
Fig. 15. Comparison of beach contours measured on 2010/04/17 (left-hand drawing) and 2011/04/10 (central drawing), and the difference between them (right-hand drawing) after the set-up of the first two devices (Unit: m).

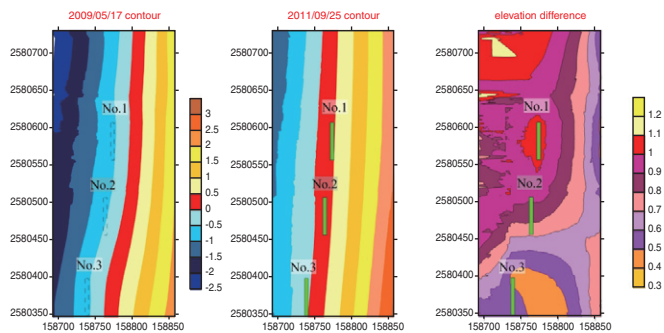
Fig. 16. Comparison of the beach contours measured on 2009/05/17 (left-hand drawing) and 2011/09/25 (central drawing), and the difference between them (right-hand drawing) after the set-up of the three devices (Unit: m).

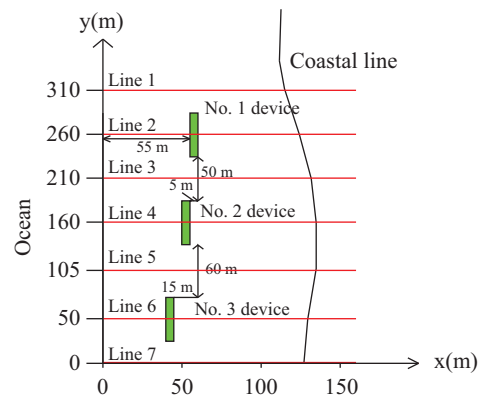
Fig. 18. Assigned profile lines for studying temporal and spatial variations in beach elevation.

To understand the distribution of sediment deposition, we transversely sliced the field-study area into 7 profile lines (as shown in Fig. 18), from profile line 1, located about 25 m to the north of No. 1 device, to profile line 7, located about 25 m south of No. 3 device. Profile line 2 is located transversely along the center line of No. 1 device; profile line 3 is located transversely along the middle between No. 1 and No. 2 devices; profile line 4 is located transversely along the center of No. 2 device; profile line 5 is located transversely along the middle

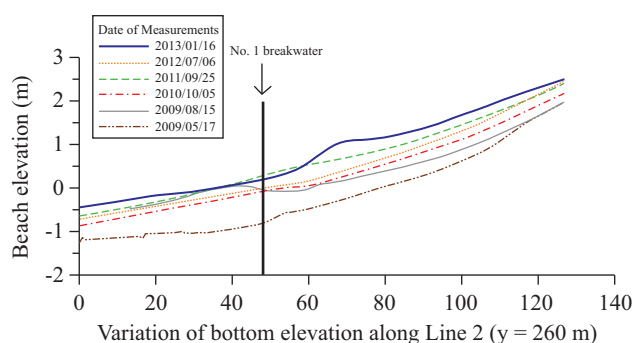
**Fig. 19. Temporal variation of beach elevation along profile line 2. Three additional measurements in 2012 and 2013 are also indicated in this figure.**

between No. 2 and No. 3 devices; profile line 6 is located transversely along the center of No. 3 device; and profile line 7 is located about 25 m south of No. 3 device. Fig. 19 gives an example of the variation in temporal beach-elevation along profile line 2. The study of beach profiles can aid in understanding the temporal and spatial variations in the beach elevation around these three breakwaters. The results shows that: (a) significant sediment deposition occurred in the first year after the device set up; (b) according to beach elevation profiles measured on 2009/08/15, this area was ever suffered severe erosion during Typhoon Morakot; (c) a comparison of the beach contours measured on August 9, 2010 and January 16, 2013 shows that the beach around the three breakwaters has accumulated sediment, but the southern part of the beach (about 50 m away from No. 3 flexible breakwater), where the area is out of breakwater protection, continued to suffer sediment erosion.
