# ASSESSMENT OF ASPHALT CONCRETE PAVEMENT QUALITY BY USING INFRARED THERMAL IMAGING TECHNOLOGY

Key words: infrared thermal imaging technology, manhole, temperature, pavement.

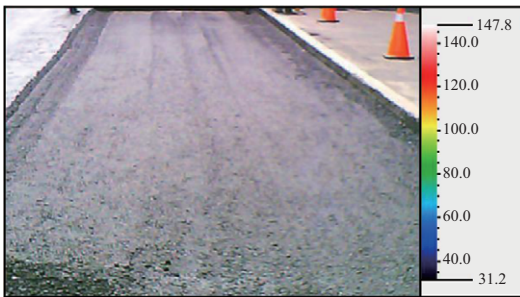
Fig. 2. Field comparison when paving.

ranges. Fig. 1 offers a thermal image diagram, and Fig. 2 presents a field comparison photograph. As these figures show, when asphalt concrete pavement is visually observed, any temperature differences cannot be clearly determined. Fig. 3 offers a photograph of the infrared temperature-sensing gun that was used to detect the temperature. As mentioned, an infrared temperature-sensing gun can detect the temperature of asphalt concrete, but only in a pointwise manner. Obtaining accurate data and determining the section or area that corresponds to the minimum temperature is difficult. However, infrared thermal imaging technology can facilitate the issue by clearly detecting temperature changes in paving.

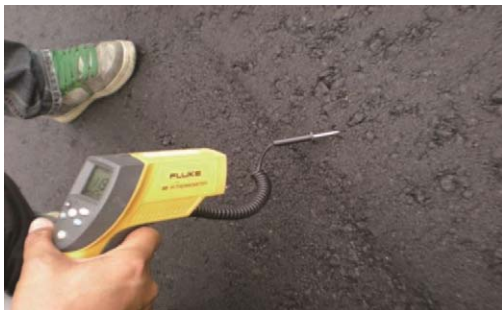
Fig. 3. Detecting with infrared temperature-sensing gun.

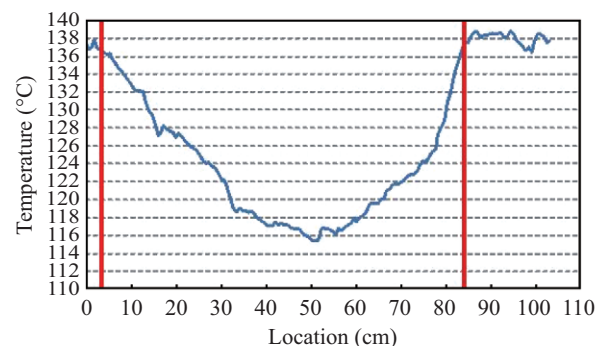
Fig. 10. Thermal imaging analysis while paving above manhole cover.

Figs. 9 and 10 show the thermal image analysis results for the condition of asphalt concrete that is paved over manholes. The figure reveals that the presence of manhole covers underneath the asphalt concrete pavement led to a decreased in the temperature on the surface of the asphalt concrete pavement at the location of the manhole covers, with temperature

Fig. 10 corresponds to Fig. 9 and shows that the two edges of the manhole cover are located at 4 and 84 cm. The maximum temperature was approximately 139°C and was observed above the asphalt concrete pavement close to the manhole at locations 88 and 95 cm. The lowest temperature observed over the center of the manhole cover at 52 cm, at approximately 115°C, indicating a difference of approximately 24°C. The temperature was low at the center of the manhole because the airflow under the manhole created a cooling effect.

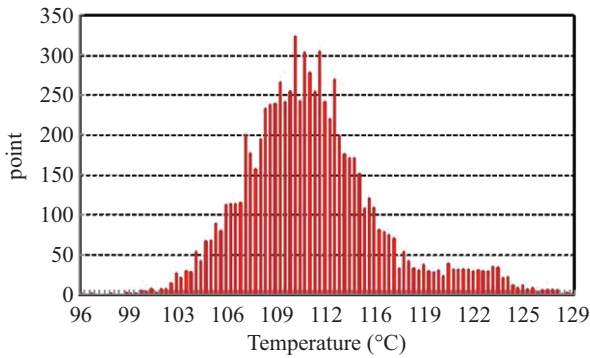
**Fig. 11. Covered canvas temperature distribution chart.**

In this study, a thermal imaging inspection system was used to assess the influence of a canvas cover on temperature changes in an asphalt mixture during transportation. Figs. 11 and 12 show thermal image temperature charts (temperature distribution at different points is plotted on the vertical axis, and temperature is plotted on the horizontal axis) for trucks carrying covered and uncovered conventional asphalt mixtures, respectively. The time required to transport the asphalt mixture from the mixing plant to the paving site was 30 minutes, and included highway travel for 20 minutes. During transportation, the temperature of the uncovered conventional asphalt mixture dropped to 24°C (on average), indicating that the absence of a canvas cover affected the asphalt mixture temperature. A comparison of Figs. 11 and 12 illustrates that the average surface temperature of the asphalt mixture with a canvas cover was approximately 24°C higher than without a canvas cover, thus confirming that canvas covers will reduce the rate of heat loss during transport.

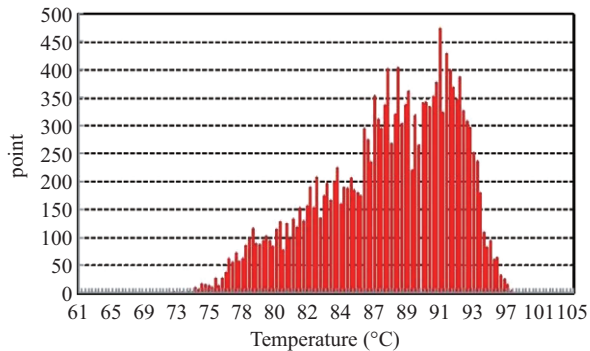
**Fig. 12. Uncovered canvas temperature distribution chart.**

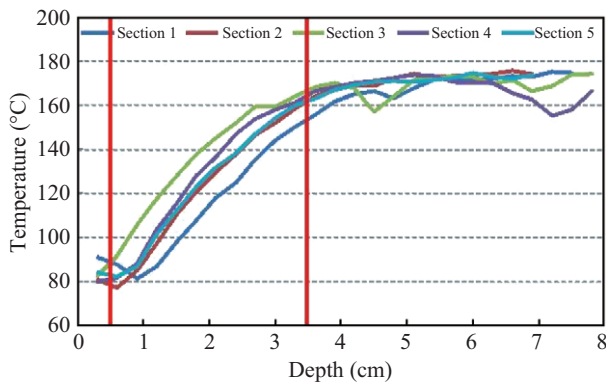
Fig. 16. Changes in surface and interior temperature in the transporter.

Asphalt mixtures segregate mainly due to the presence of a localized large amount of fine or coarse aggregates and an uneven distribution of aggregates and asphalt. Aggregate segregation predisposes a road to early damage. Fig. 15 illustrates the difference in temperatures between the surface and the interior, determined by infrared thermal imagery, of an asphalt mixture in a transporter. In general, the temperature of the asphalt mixture was between 155 and 170°C at the milling plant. As Fig. 16 shows, the temperature of the asphalt mixture was measured in five sections to avoid sampling bias. The horizontal axis indicates temperature changes in the asphalt mixture based on depth, and the vertical axis indicates the temperature in the five sections. The surface temperature distribution was  $81 \pm 6^\circ\text{C}$ . Compared with the temperature of the asphalt mixture at the milling plant (155 to 170°C), the surface temperature of the asphalt mixture dropped to  $81 \pm 6^\circ\text{C}$  because the surface area came in contact with air, which cooled the mixture during transportation. Yet, the temperature remained high in the deep layers of the asphalt mixture.
