CRITICAL ASSESSMENT OF JOINTED PLAIN CONCRETE PAVEMENT PERFORMANCE USING 40-YEARS OF CONDITION EVALUATION DATA

Key words: JPCP, design features, pavement life, field pavement performance data.

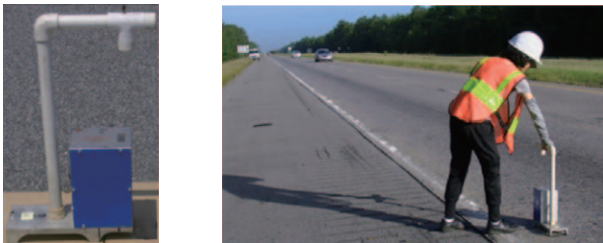
Fig. 1. Georgia Faultmeter.

The annual survey consists of measuring joint faulting and counting pavement defect occurrences in outside lanes for each mile of JPCP in Georgia (GDOT, 1993). The faulting of every eighth joint is measured using a Georgia Faultmeter to obtain representative samples of each mile of JPCP. The Georgia Faultmeter, as shown in Fig. 1(a), was designed, developed, and built by GDOT's Office of Materials and Research in 1987 to simplify measuring JPCP joint faulting (Stone, 1991). The electronic digital faultmeter is placed on

(a) The Georgia fault meter (b) Manually measure faulting on the roadway

the joint at 1 ft from the pavement marking edge to measure the difference in elevation to the nearest 1/32 inches between the pavement surfaces on either side of a transverse joint, as shown in Fig. 1(b). It reads out directly in 32nd of an inch (e.g., a digital readout of “3” indicates 3/32 inches of faulting). This accuracy was chosen because it was difficult to read the dial gages used in the original manual model to any better accuracy. The Georgia Faultmeter is the most popular handheld device for measuring faulting and has been adopted by many state DOTs (e.g., Minnesota DOT) and the Long-term Pavement Performance (LTPP) program for measuring JPCP joint faulting. For every mile of JPCP, a faulting index that represents the total faulting of a hypothetical five joints per mile is reported. The faulting index is computed as five times the sum of all readings divided by the number of readings (Eq. (1)). A faulting index of 15 is equivalent to an average faulting of 3/32 inches (2.4 mm) in one mile.

$$F.I. = 5 * \left(\frac{\sum \text{faulting reading of every 8th joint}}{\text{number of faulting readings}} \right) \quad (1)$$

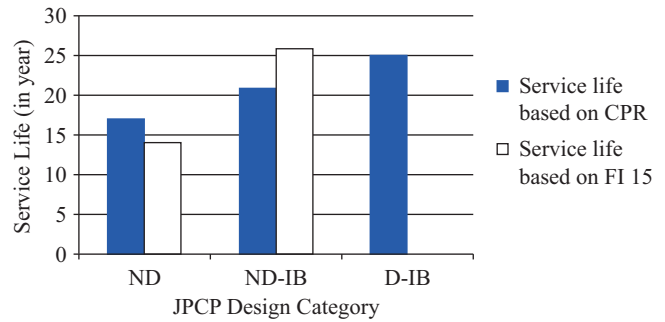
Fig. 3. Service lives of different design categories.

The service life for each design category of the total of 837 surveyed miles of JPCP is summarized in Table 4. Among them, the 440 surveyed miles of ND constructed between the 1960s and early 1970s had already reached the end of service life (i.e., have had at least one major CPR) by 2010. The average service life of ND based on time to reach CPR is 17 years, shorter than the 20-year design period. The faulting index before a major CPR is 16.8, an increase of faulting at an average rate of approximately 1 faulting index per year. The service life based on a faulting index of 15 is approximately 14 years, shorter than the one based on CPR. Also, the deterioration in the faulting index varies greatly among the 440 surveyed miles of ND.

The 183 surveyed miles of ND-IB constructed in the 1970s have an average service life of 21⁺ years (based on CPR), which is 23% longer than that of ND pavements. The faulting index before major CPR is about 12, lower than a faulting index of 15 or 20 as used in the MEPDG default. The service life based on a faulting index of 15 is approximately 26 years, which is 83% longer than that of ND pavements (14 years). This indicates ND-IB has substantially mitigated the faulting issue. It is noted the IRI before the CPR is high, but only limited broken slabs were recorded before the CPR activities.

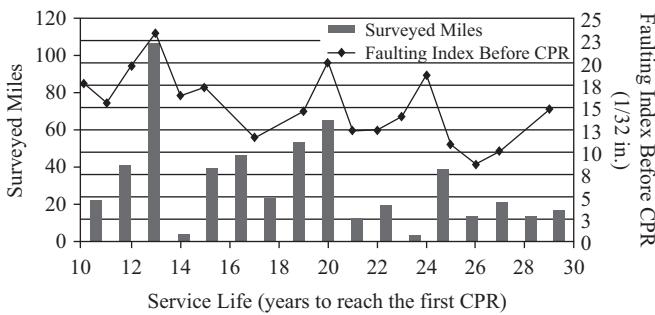
Fig. 2. Distribution of service life with faulting index before the CPR.

The service life, i.e., the time to reach the first major CPR, was determined for the 837 surveyed miles of JPCP. Fig. 2 shows the distribution of the service life by year along with the faulting index before CPR. Fig. 2 shows a broad service life ranging from 10 years to 29 years. More than 50% of the pavements are rehabilitated between 12 and 20 years. The faulting index before the CPR also varies from 9 to 24 without a particular pattern. This indicates the timing of CPR depends not only on pavement condition but also other factors, such as funding availability, adding lane(s), etc. Therefore, the time to

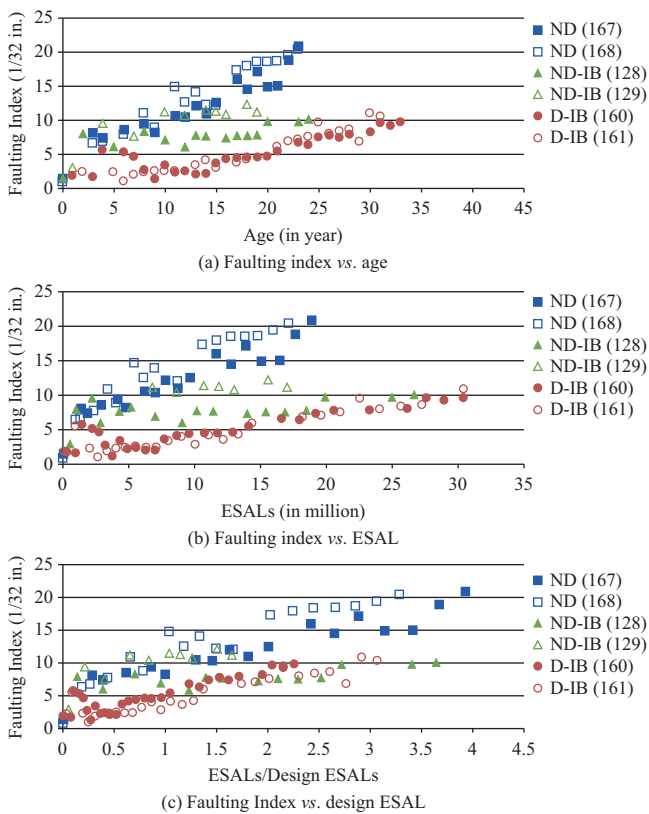
Fig. 4. Faulting index by age, ESAL, and design ESAL.

Projects 167 and 168, constructed with ND on a 6-inch soil cement base, lasted 23 years before the first major CPR. Both projects reached a faulting index of 20 and carried roughly 20 million ESALs, which is 3 times the designed ESALs, in the first 23 years before the first major CPR. The deterioration rate in the faulting index is 0.9 per year and 1.1 per million ESALs, as shown in Table 6 and Table 7. Fig. 4 shows the plots of the faulting index versus age, cumulative ESALs, and design ESALs. The deterioration in the faulting index for ND, in terms of year and ESLAs, is higher than that of ND-IB and

D-IB. However, the cumulative ESALs have exceeded the design ESALs upon which the pavement thickness and design features are based. The pavements carried approximately 3.5 times the designed ESALs before the first major CPR. Overall, these two projects carried more than 3 times the designed ESALs for each project before the first major CPR with significant faulting developed in 20 years.

when the faulting index was roughly 10. Project 128 carried 26 million ESALs (3.5 times the designed ESALs) over 26 years; Project 129 carried 19 million ESALs (1.6 times the designed ESALs) in 17 years, as shown in Table 5. Both projects have a deterioration rate in the faulting index of less than 0.6 per year and 0.7 per million ESALs. Fig. 4. shows the faulting index deteriorates at a very slow rate in both time and ESALs, especially for Project 128.

Projects 160 and 161 were constructed with D-IB (1-inch HMA interlayer and 5-inch soil cement base). Both projects have carried more than 30 million ESALs, which is about 2.7 times the designed ESALs, over 30 years without a major CPR. They are still in fairly good condition with a faulting index of approximately 10. These two projects have a steady, low deterioration rate in the faulting index of 0.3 per year and 0.3 per million ESALs. The service lives of these two projects are expected to be more than 40 years if a faulting index of 15 is the end of service life for triggering the first CPR.
