Fire Resistance of Steel Connectors of Precast Lightweight Concrete Walls

Chi, Jen-Hao; Chi, Maochieh; and Huang, Yue-Lin (2021) "Fire Resistance of Steel Connectors of Precast Lightweight Concrete Walls," *Journal of Marine Science and Technology*. Vol. 29: Iss. 4, Article 4.

RESEARCH ARTICLE

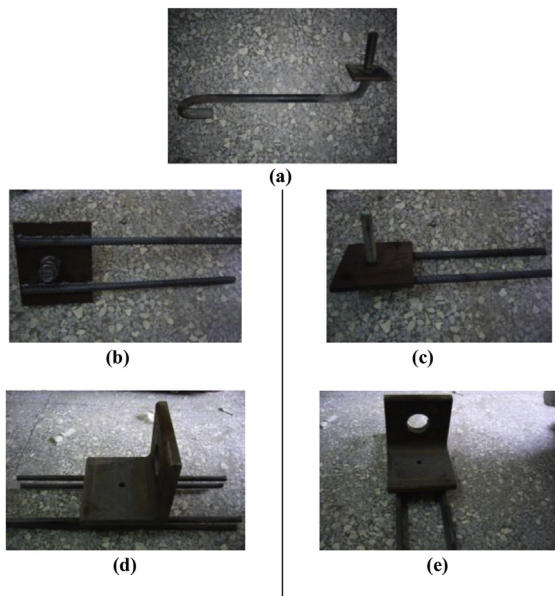
Fig. 1. Display of the steel connectors in this study (a) photo of the dry type (61) (b) top view's photo of the wet type (81) (c) side view's photo of the wet type (81) (d) top view's photo of the bearing type (56E) (e) side view's photo of the bearing type (56E).

In practice, the dry (61) and wet (81) connectors are only subject to tensile force, whereas the bearing (56E) connector is subject to both tensile and shearing forces. Photographs of various steel connectors are displayed in Fig. 1.

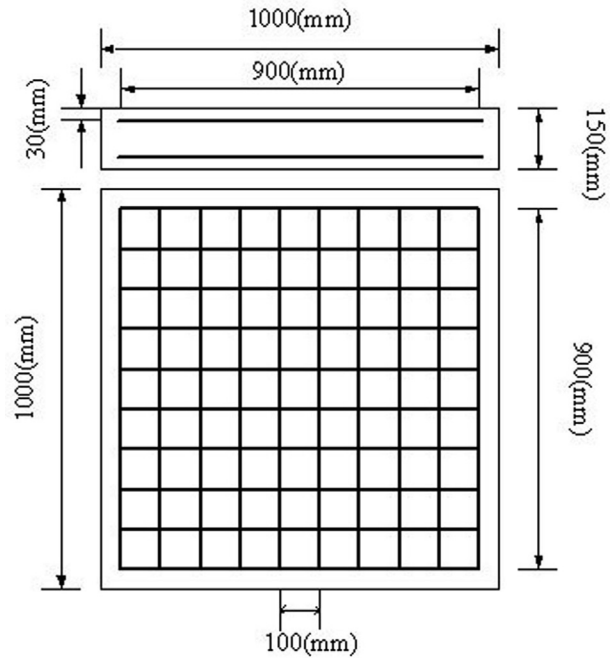
Fig. 2. Specimen size of the schematic diagram.

The specimens were 30-m thick and had dimensions of 1000 × 1000 × 150 mm³ (L × W × H), as displayed in Fig. 2. The steel connector was placed between two pieces of wire mesh, and the reinforced steel was added around the hole. All sample numbers and experimental items are listed in Table 2.

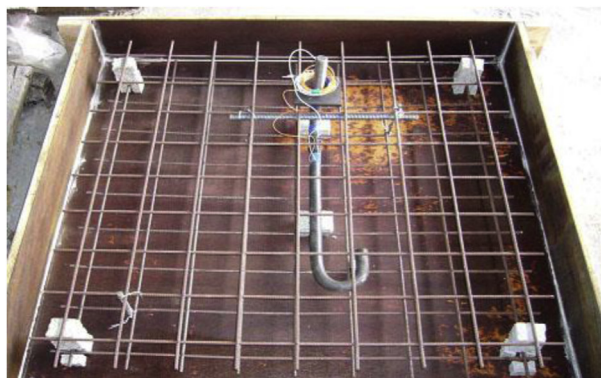
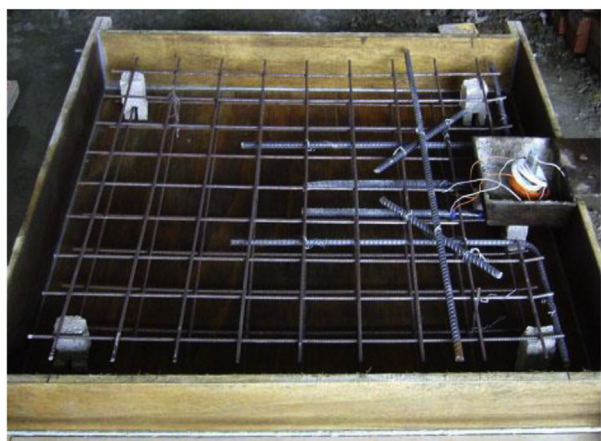
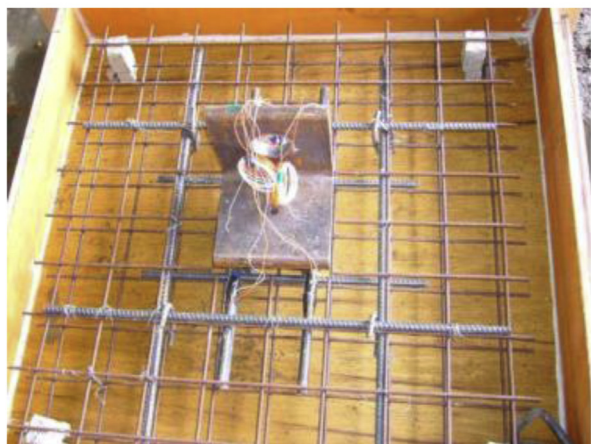
Fig. 3. Configuration of steel connectors within wall specimen (a) dry type (61) (b) wet type (81) (c) bearing type (56E).

The configuration of steel connectors within the wall specimens are displayed in Fig. 3. Wooden molds were used because of the number of wall specimens and workability requirements.

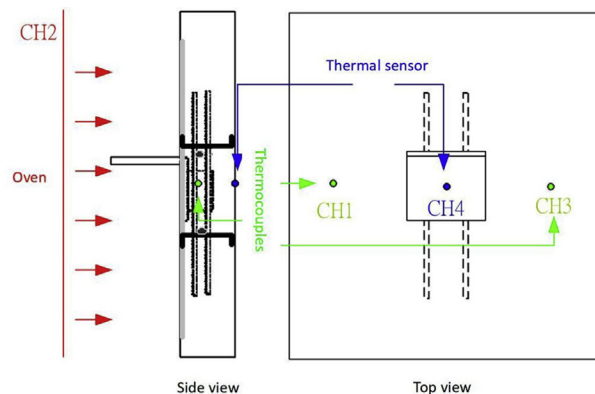
Fig. 4. The location of measuring point for specimens in the fire resistance test.

the high-temperature furnace matched the ASTM E119 curve (Fig. 5). Thermocouples (K type, AZ-8855) CH1 and CH3 and a thermal sensor CH4 were arranged as displayed in Fig. 4. The internal and external temperature changes in the wall under heating are displayed in Fig. 5. After the fire resistance test, the wall sample was removed from the furnace for further testing.

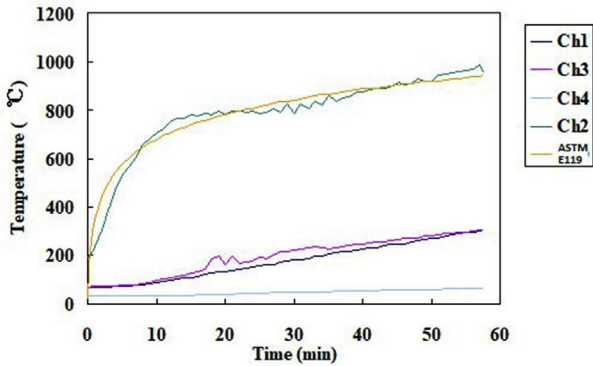
Fig. 5. The rising temperature curve of specimens in the fire resistance test.

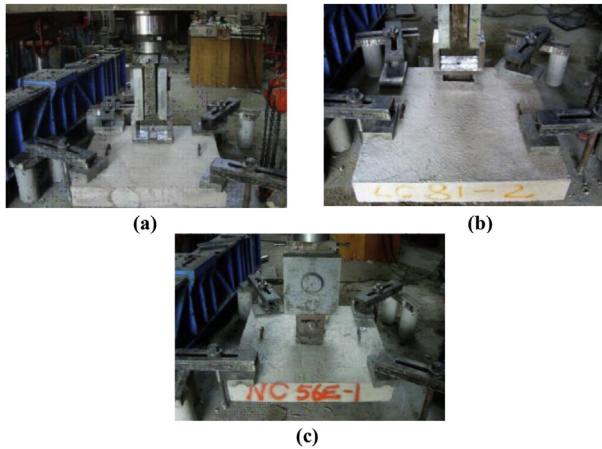
Fig. 6. Photos of tension test of wall specimens (a) dry type (61) (b) wet type (81) (c) bearing type (56E).

First, the tension mold was installed on a 600-ton MTS universal testing machine, and the wall specimen was lifted at the test site using a stacker. The connector on the wall penetrated into the tension mold. A strong bolt was passed through the tension mold and the connector. The nut was then locked. The wall specimen was suspended on the aforementioned MTS universal testing machine by using the connector and tension mold. Then, the wall specimen was gently lowered to the rail; the four ends of the wall specimen of the fixed wall were used to lock the test specimen to the high-strength floor surface. After the strain gauges and other measuring devices were appropriately arranged, the tension test was performed, as illustrated in Fig. 6. The displacement control pulled the samples up at a rate of 0.03 mm/s. The measured data of the displacement and tension values were processed in the data collection system and analyzed.

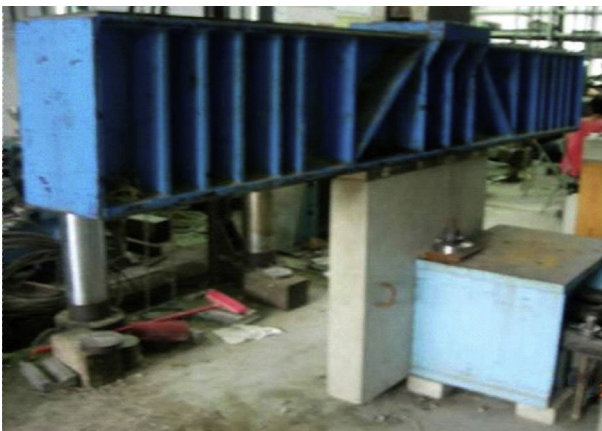
Fig. 7. Photo of shearing test of the bearing type (56E).

eccentricity, the base was fixed using the groove steel seat and the bolt. A stacker was used to hang the wall specimens upright on the base, as displayed in Fig. 7, and the bolts were tightened. A strain

When the shearing test was performed on LC56E)V2b and NC(56E)V2b, the failure patterns of the two specimens were similar. As illustrated in Fig. 7, the center of the wall and the base were not in the same line. Due to the eccentric action, when the wall moved downward, the reaction force of the base generated an eccentric bending moment to the connector. The aforementioned bending moment exerted pressure on the concrete above the steel connector and generated a tensile force below. Furthermore, when the wall moved downward, the wall and connector interface produced an upward shear force, which in turn caused a shear force on the concrete above the connector. This shear force caused a pull force on the lower side. In summary, the concrete above the connector was subjected to pressure and shear force simultaneously; its failure patterns are displayed in

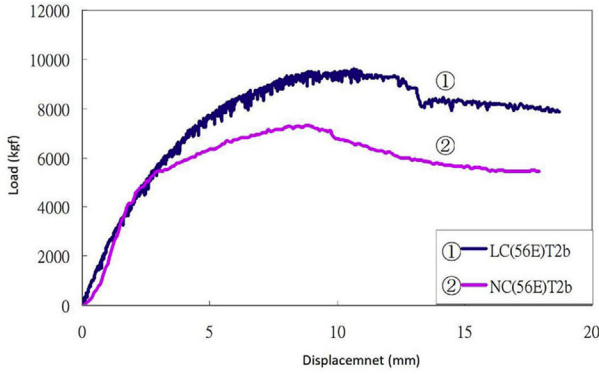
Fig. 8. The load–displacement ($P-\Delta$) curve of the bearing type (56E) specimen for tension test after fire resistance test.

As listed in Table 5, the P_{cr} of LC(56E)T2b and LC(56E)T1 was 4568 and 5501 kgf, respectively; the ratio of P_{cr} of the two specimens was 4568/5501 = 83.0%; the P_u values of the two specimens were 9510 and 11,184 kgf, respectively; the ratio of their ultimate loads was 9510/11,184 = 85.0%. When subject to high temperature, the decrease of the two strengths was small, indicating that the light specimen has excellent fire resistance. Similarly, the cracking loads of NC(56E)T2b and NC(56E)T1 were 4233 and 5536 kgf, respectively; the ratio of the cracked load was 4233/5536 = 76.5%; P_u was 7310 and 11,642 kgf, respectively, and the ratio of the cracked load was 7310/11,642 = 62.8%. A similar phenomenon was observed for the NWC

Regarding ductility, as evident in Table 5, the Δ_{max}/Δ_u ratios of LC(56E)T2b and LC(56E)T1 were 2.5 and 4.97, respectively. The Δ_{max}/Δ_u ratios of NC(56E)T2b and NC(56E)T1 were 2.88 and 3.72, respectively. The ductility ratio losses of NC(56E)T2b and NC(56E)T1 were higher than those of the LWC wall. However, as displayed in Fig. 8, after the fire test, the load–displacement curve (the area covered by the load–displacement [$P-\Delta$] curve [i.e., the hysteresis energy referred to in [23,36] was considerably larger than that of the NWC wall. Under the same conditions, the absorbed hysteresis energy and seismic resistance of the LWC wall were still higher than the NWC wall.

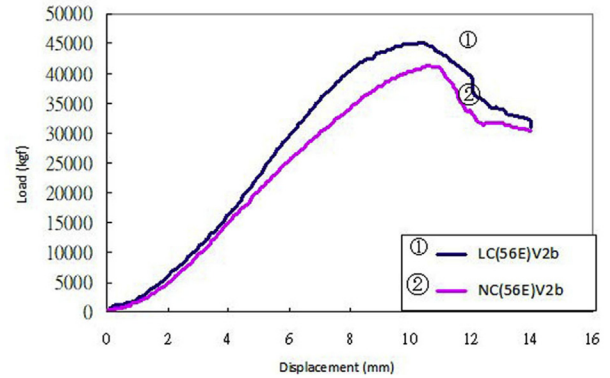
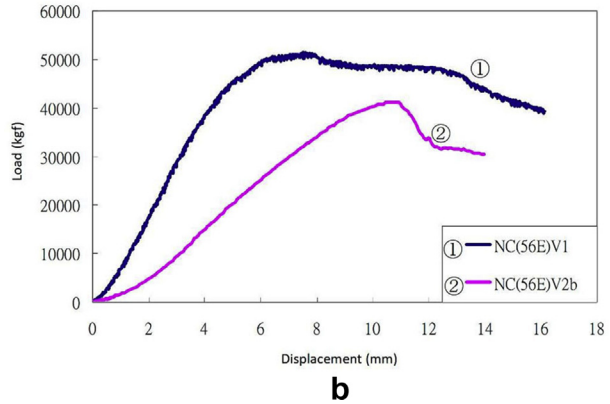
Fig. 9. The load–displacement ($P-\Delta$) curve of the bearing type (56E) specimen for shearing test (a) lightweight and normal weight wall after the fire resistance test (b) before and after the fire resistance test for normal weight wall.

As presented in Table 6, the Δ_{max}/Δ_u ratios of LC(56E)V2b and NC(56E)V2b were 1.17 and 1.10, respectively. As displayed in Fig. 9(a), the area covered by the load–displacement curve of LC(56E)V2b (i.e., the hysteresis energy), was still larger than that of NC(56E)V2b. Under the same conditions, the hysteresis energy that can be absorbed and the

seismic resistance of the LWC wall were still higher than those of the NWC wall. Fig. 9(b) displays that the NC(56E)V2b and NC(56E)V1 specimens exhibited a large difference in the area covered by the two load–displacement curves before and after the tests. Thus, the NWC walls exhibited a large decrease in hysteresis energy and seismic resistance.

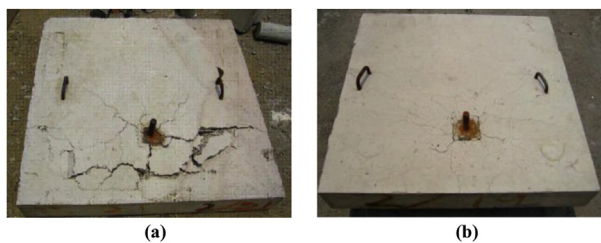
Fig. 10. The failure patterns of the dry type (61) specimen for tension test after the fire resistance test (a) specimen LC(61)T2b (b) specimen NC(61)T2b.

The crack growth condition, shape, position, direction, and specimen failure of LC(61)T2b and NC(61)T2b were similar. When the tensile force was lower than the cracked load, the tensile force and joint displacement maintained a linear relationship. As the tensile force approached the cracked load, cracks began to form on the concrete surface around the connector, as displayed in Fig. 10(b). The cracks gradually extended, the width of the cracks increased, and the concrete protective layer on the wall surface began to collapse. The concrete function was gradually lost. Most of the tensile force was transferred to the joint of the iron and steel inside the wall until the sample was destroyed, as presented in Fig. 10(a). The cracks and damage related to the specimen are displayed in Fig. 10.

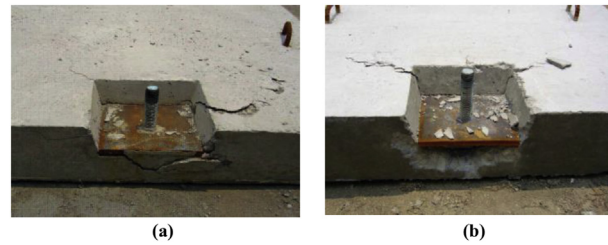
Fig. 11. The failure patterns of the wet type (81) specimen for tension test after the fire resistance test (a) specimen LC(81)T2b (b) specimen NC(81)T2b.

The LC(81)T2b connector did not have any reinforcement mesh or concrete protection layer; when the tensile force was lower than the cracked load, the tension and displacement maintained a linear relationship. As the tension increased to the cracked load, the concrete underneath the steel connector began to crack. When the tension load equaled the cracked load, the connector was pulled, and the turning trend of the strain increased. As the experiment progressed, the cracks gradually extended, the width of the cracks increased, and the concrete protective layer on the surface of the specimen

began to collapse, as displayed in Fig. 11(a). The tensile force was mostly concentrated on the steel connector until the structure was destroyed.

The phenomena of crack growth, shape, position, direction, and destruction of NC(81)T2b were similar to those of LC(81)T2b, but the cracked load and ultimate load were both lower than those of LC(81)T2b. When the wall was subjected to a tension test, the first obvious crack occurred in the concrete at the bottom of the connector. In addition to the tensile force at the connector, a bending moment occurred at the connector between the connector and the concrete. The final failure pattern was a reverse cone below the connector, as displayed in Fig. 11(b). In addition to the upward displacement caused by the vertical tension at the connector, a slight angle of inclination due to the bending moment also occurred. The cracks and damage of the wall specimens are displayed in Fig. 11.

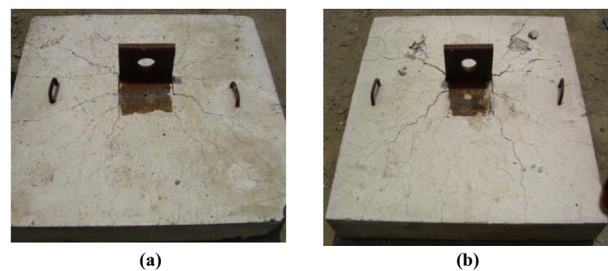
Fig. 12. The failure patterns of the bearing type (56E) specimen for tension test after the fire resistance test (a) specimen LC(56E)T2b (b) specimen NC(56E)T2b.

connector differed from that in the rear reinforcement. As the experiment progressed, the cracks gradually extended; the width of the cracks increased and extended to the periphery, as displayed in Fig. 12(a). The concrete surface of the specimen began to collapse, and most tensile force was transferred to the steel connectors until the specimen was destroyed, as displayed in Fig. 12(b).

When LC56E)T2b and NC(56E)T2b were subjected to tension tests, the failure patterns of the two specimens were similar. In addition to the upward vertical tension force, the connectors produced a bending moment. The reinforcement on the back of the connector could withstand the upward vertical tension and bending moment. Therefore, the concrete on the back of the connector caused serious damage and breakout. In Fig. 12(b), the damage on the back of the connector was severe. By contrast, only concrete cracks were generated on the front concrete of the connector and no obvious failure patterns were observed, as displayed in Fig. 12(a). The cracks and damage of wall specimens are displayed in Fig. 12.

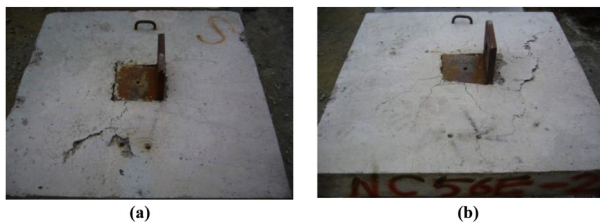
Fig. 13. The failure patterns of the bearing type (56E) specimen for shearing test after the fire resistance test (a) specimen LC(56E)V2b (b) specimen NC(56E)V2b.

Fig. 13(b). Conversely, the concrete under the connector was subjected to two-way tensile forces simultaneously. The failure patterns are displayed in Fig. 13(a). As displayed in Fig. 13, the cracks produced in the NWC wall were more pronounced than those in the LWC wall; after the specimen was destroyed, the steel connectors were slightly inclined because of the bending moment.
