BIODETERIORATION OF COASTAL CONCRETE STRUCTURES BY MACRO ALGAE - ULVA FASCIATA

Jayakumar, Stri Hari Babu; Saravanane, Rama; and Sundararajan, Thirumalai (2011) "BIODETERIORATION OF COASTAL CONCRETE STRUCTURES BY MACRO ALGAE - ULVA FASCIATA," *Journal of Marine Science and Technology*: Vol. 19: Iss. 2, Article 7.

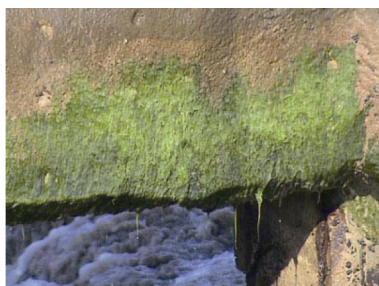
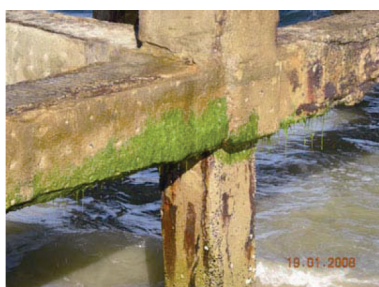
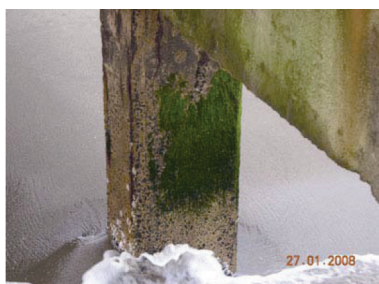
Fig. 1. Growth of marine seaweed on structural components.

Fig. 2. Growth of marine seaweed on structural components.

Fig. 3. Growth of marine seaweed on structural components.

Puducherry is an Indian coastal region on the Bay of Bengal. There are many marine structures located in the coastal area. These structures deteriorate due to the macro flora present in the sea water as shown in Figs. 1, 2, 3 [3, 4, 6, 7]. Though a secondary deterioration process, there is significant effect due to this macro flora [9, 15, 16]. The ambient condition prevailing in the coastal area helps the growth of *U. fasciata* round the year. The growth of *U. fasciata* on concrete struc-

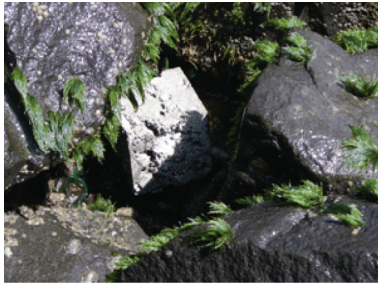
Fig. 4. Natural culture of the marine algae *U. fasciata* on concrete cube.

- To culture *U. fasciata* naturally, several concrete cubes were kept in coastal area where there was abundant growth of *U. fasciata* (Fig. 4)
- Concrete cubes were allowed to cure in ordinary water.
- Laboratory simulation has been carried out to culture the

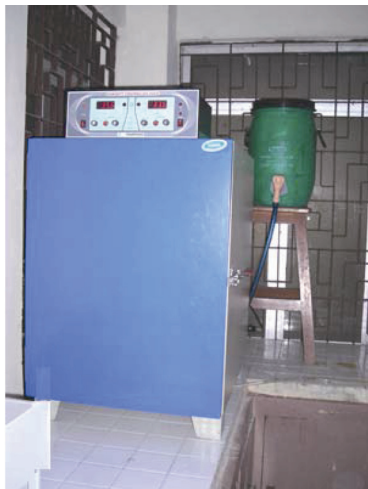
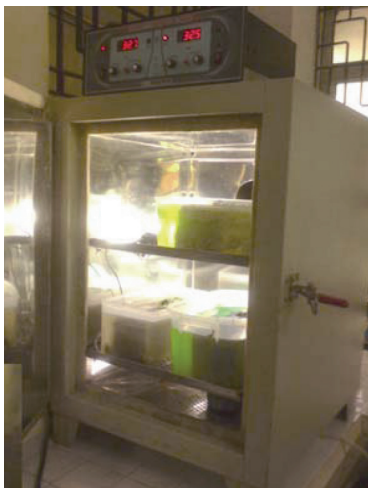
Fig. 5. Laboratory culture of the marine algae *U. fasciata* on concrete cube.

Fig. 6. Laboratory culture of the marine algae *U. fasciata* on concrete cube.

macro algae on the concrete cube. For the simulation, Humidity oven was used (Figs. 5, 6). The details of oven are as follows:

The ambient condition maintained in the chamber is as follows. Samples were incubated under lighting conditions of 2000 lx, 12 h/day with a “daylight” with white fluorescent lamp. The temperature is maintained at 30°C. The relative humidity is maintained as 90% [3].

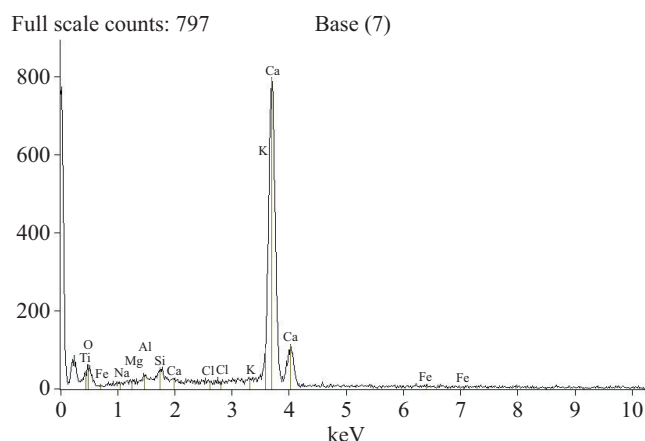
Fig. 13. EDAX of *U. fasciata* attached concrete surface in natural condition.

EDAX results depicted above Tables 2, 3 and 4 elucidate that the base material has been modified. In the case of concrete cubes cured in ordinary water (control concrete) the silica level is 10.37% atom while calcium level is 9.18% atom. The EDAX results of the algal affected concrete in natural condition shows that the calcium level has tremendously increased to 46.06% atom while silica level has been decreased to 1.29% atom [6, 16]. While in the case of simulated condition, calcium level has tremendously increased to 44.01% atom while silica level has been decreased to 4.23% atom.

This proves that the calcium level in the algal affected concrete surface in natural condition has increased tremendously. This high level of calcium is due to dissolution of calcium in concrete by organic acid produced by marine chlorophyceae *U. fasciata* and precipitation of the organic salt upon dehydration. This is an indication of the alteration of the base material.
