SIPHONING SEA WATER BACK INTO THE ENGINE IN FAST BOATS

Osman Azmi Ozsoysal

A failure investigation has been conducted on the exhaust system of a high speed marine diesel engine in Turkish ambulance boats. Premature failures were reported on the poor starting, on the loss of power, on the lubricating oil leakage and on the engine overload. It was observed some significant tracks of sea water found its way into the exhaust passages from condensation of the salt water vapour and also from entering some sea water into the exhaust system. In order to initiate a more accurate cause investigation, the engine went through an overhaul inspection, in which it was determined that there were corrosion and some deposits throughout the exhaust system. After performing the systematic cause analysis of the engine damage, it is concluded that erroneous design decisions cause to siphon sea water back into engine, doing expensive damage. Ever since water has been used to cool exhaust gases, there will be many cases of engines flooding with water from the exhaust system. Recognizing the potential problems mentioned in this paper, a wet-exhaust system is recommended to keep water out of all small and

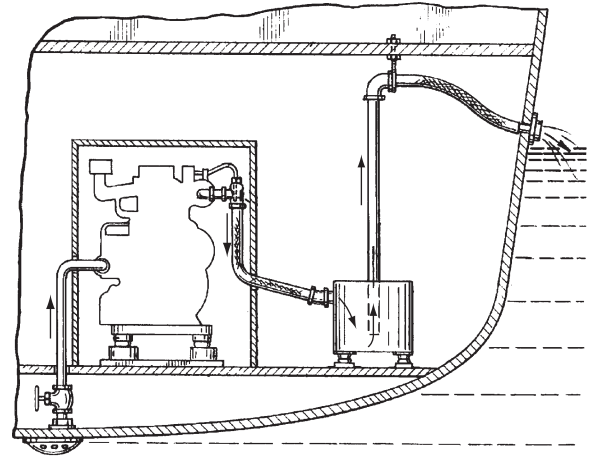
Several researchers introduced several ideas about preventing any raw water siphoning back to engine through exhaust outlet. United States Patent Office has just approved total 21 patent application since 1967. The first patent request proposes to discharge the sea together with the exhaust gas after decreasing its high temperature to an acceptable level [6]. The basic logic how it works can be clearly seen from the sketch in Fig. 4. The latest patent application [7] on same subject was confirmed in 2006.

Fig. 4. The first idea on the wet exhaust for small crafts [6].
