Case Study of Coastal Erosion and Measures at Kezailiao Coast, Taiwan

REVIEW

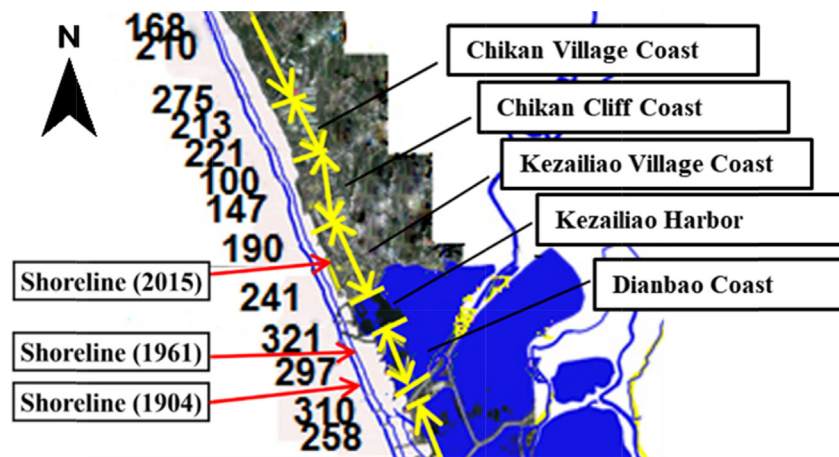
Fig. 3. Shoreline changes at Kezailiao coast over 111 years from 1904 to 2015.

Based on the analysis of administrative district and topographic maps, the shoreline with a narrow beach was almost parallel to the cliff at a distance ranging from 51 m to 72 m in 1903, as shown in Fig. 5. From Fig. 3, it is clear to see that the shoreline retreat has ranged from 100 m to 275 m at Chikan Cliff Coast. The maximum shoreline recession was 275 m from 1904 to 2015 (see Fig. 3). By comparing the positions of the coastal cliff between 1903 and 2002, as shown in Fig. 5, it is evident that the shoreline continuously retreats distances varying from 18 m to 66 m in the period from 1975 to 1982.

Up to now, the shoreline has reached the toe of the coastal cliff. Continuous erosion has occurred for almost a hundred years according to the analysis from overlapped maps. Average beach erosion in the Chikan Coast was around 2.8 m per year during the 111 year period. Coastal cliff recession slowed down after the completion of 5 units of detached breakwaters built from 1981 to 1983 (see Fig. 5).

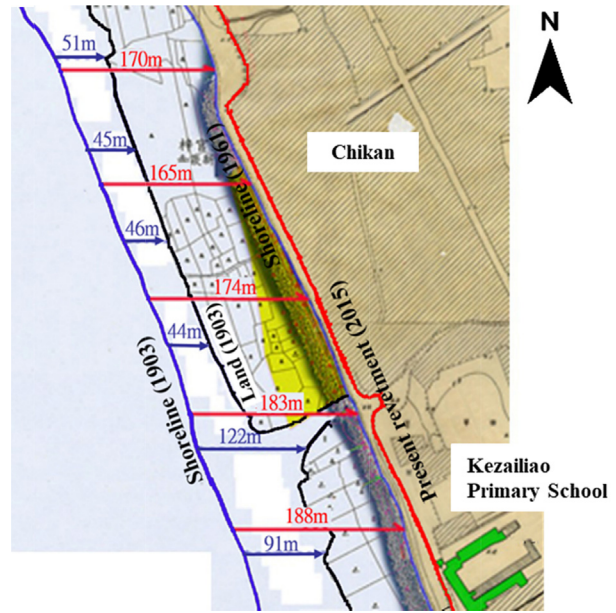
Fig. 6. Analysis of shoreline changes (1903–1961) using district maps of Chikan village coast.

Fig. 6 shows temporal and spatial shoreline changes at Chikan Village Coast. Note that the distance between the shoreline and land varied in the range of 44 m–122 m in 1903. The shoreline recession varied significantly from 165 m to 188 m from 1903 to 1961. To prevent serious beach erosion, a stockpile of armored blocks was installed in front of the revetment. It is interesting to note that the shoreline is approaching the revetment because of the defense of the armor units. Therefore, no significant shoreline change has occurred since 1961.

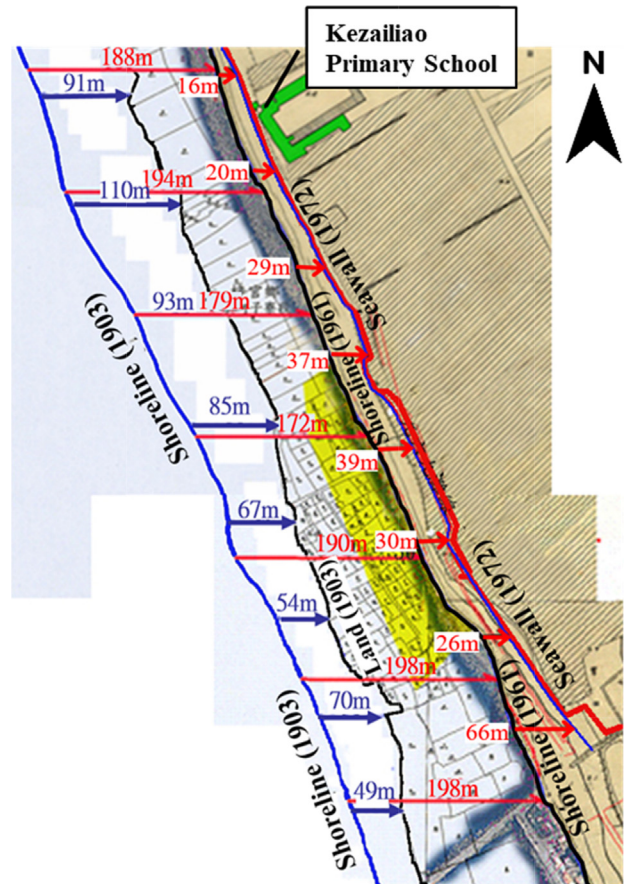
Fig. 7. Analysis shoreline changes (1903–1972) using administrative district maps at Kezailiao coast.

Temporal and spatial shoreline evolution at Kezailiao Village Coast is depicted in Fig. 7. The distance of the shoreline in 1903 to the land varied from 48 m to 110 m. The shoreline retreat varied in the range from 172 m to 198 m from 1903 to 1961, but the recession slowed down to intervals of 18 m–72 m from 1961 to 1972. The shoreline has not changed since 1972 because it is approaching to the large amount of armored blocks for built for coastal prevention.

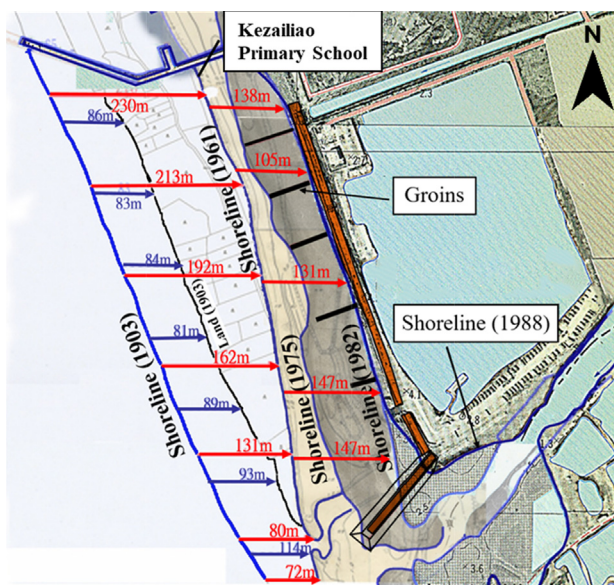
Fig. 8. Analysis of shoreline changes (1903–1988) using administrative district maps at Dianbao coast.

longshore sediments to the down drift beaches. Blockage of littoral drift by breakwaters due to the completion of Kaohsiung Harbor in 1958, Zuoying Harbor in 1948, Xinda Harbor in 1973, and Kezailiao fishing Harbor in 1978 produced destructive erosion. Fig. 8 presents the massive shoreline recession due to breakwater construction of the abovementioned harbors down drift to Kezailiao Coast, resulting in massive shoreline recession with shoreline retreat ranging from 172 m to 198 m. It is also noted that the shoreline retreat estimated from satellite image (Fig. 3) is about 300 m over the 111 years (1903–2015) following breakwater completion. The coast was eroded to the road behind which lay houses and properties built on the land. The installation of revetments covered by armor units was conducted down drift from the breakwater. This shifted the region of maximum erosion farther to the north, but beach erosion still continues.

Sand, gravel and cobble delivered from rivers are the most important resources to form a variety of accretional sandy beaches. Based on the recorded data of WRA, there has been extensive beach erosion along Kezailiao Coast largely due to the river renovations of Agongdian River, Houjingxi, Dianbao River, and Gaoping River block barriers and concrete embankments built along these rivers. It has decreased essentially all sediment supply to the coast. The resulting shoreline retreat has been significant near the Dianbao Coast. Fig. 8 shows the temporal and spatial variation of the shoreline evolution for Dianbao Coast traced from 1903 to 1982 from administrative district maps as well as

topographic maps. The overlapping of maps illustrates that remarkable beach erosion occurred along the river mouth and the whole coast.

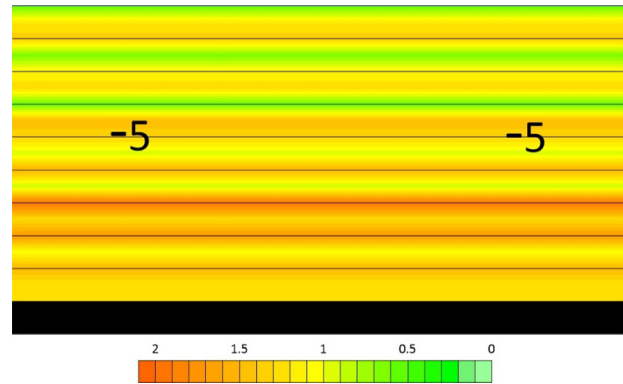
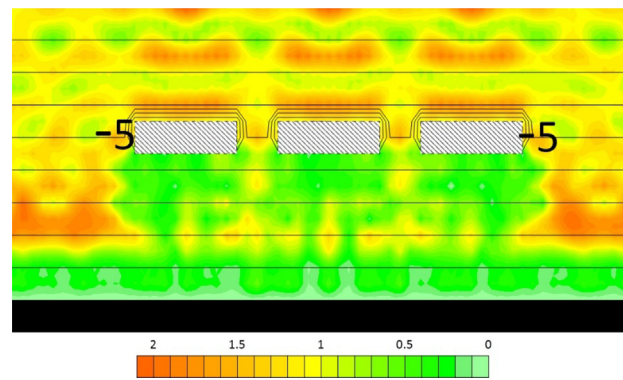
Fig. 13. Wave height distribution at the front of the sea wall.

Fig. 14. Wave height distribution after construction of 3 units of submerged breakwaters.

present a comparison of wave energy reduction between before and after the construction of submerged breakwaters. We note that submerged breakwaters are able to reduce the intensity of wave action in inshore waters by reflection, diffraction and breaking, and thereby provide safe shelter water areas. This implies that a local pair of symmetric vortices would be developed resulting in impoundment of sand behind the structure.

Numerical simulation for wave transformations and dissipation after the installation of submerged breakwater was conducted. The input wave height and period are 1.5 m and 6sec, and the prevailing wave direction is SW, respectively. Figs. 13 and 14
